BEFORE THE IDAHO PUBLIC UTILITIES COMMISSION

IN THE MATTER OF THE APPLICATION) CASE NO. AVU-E-16-03
OF AVISTA CORPORATION FOR THE)
AUTHORITY TO INCREASE ITS RATES)
AND CHARGES FOR ELECTRIC SERVICE) EXHIBIT NO. 7
TO ELECTRIC CUSTOMERS IN THE)
STATE OF IDAHO) HEATHER L. ROSENTRATER
_____)

Electric Transmission System 2016 Asset Management Plan

Mary Jensen, Rubal
Gill
Asset Management
Avista Corp.
02-01-2016

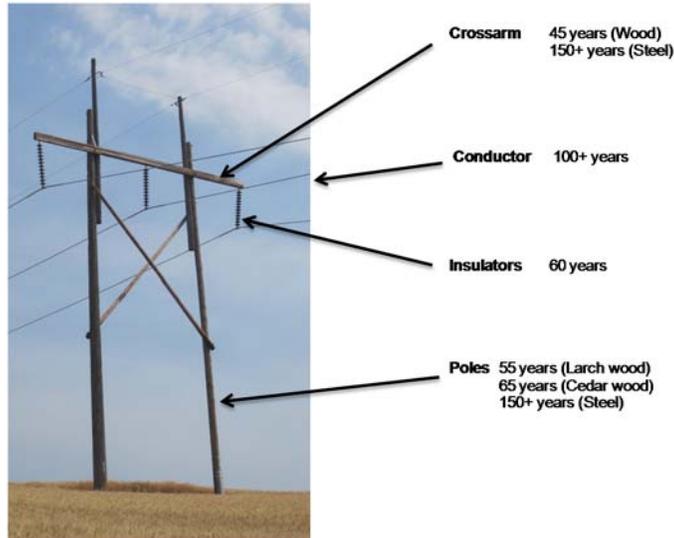
Figure 1: Example Transmission Asset Components and Expected Service Life

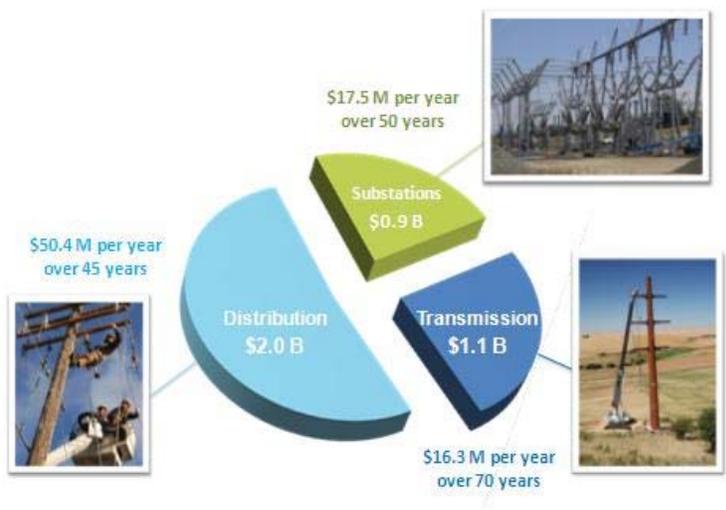
Relative to other major areas of the transmission and distribution (T&D) system, transmission assets have a longer service life, and the total replacement value of \$1.1 billion is on par with substation's \$0.9 billion and about half of distribution's \$2.0 billion. All together, levelized replacement spending is roughly \$84 million per year in perpetuity for Avista's T&D system (2014 dollars). However, as shorter lived wood materials are replaced with steel in the decades ahead, we expect overall service life to increase from 70 years to over 100 years for the transmission system. Assuming all other factors being equal, this in turn would reduce the minimum levelized spending to under \$12 million/year, roughly 50 years from now.

Figure 2: Transmission and Distribution System Replacement Values, Average Service Life, and Levelized Replacement Spending

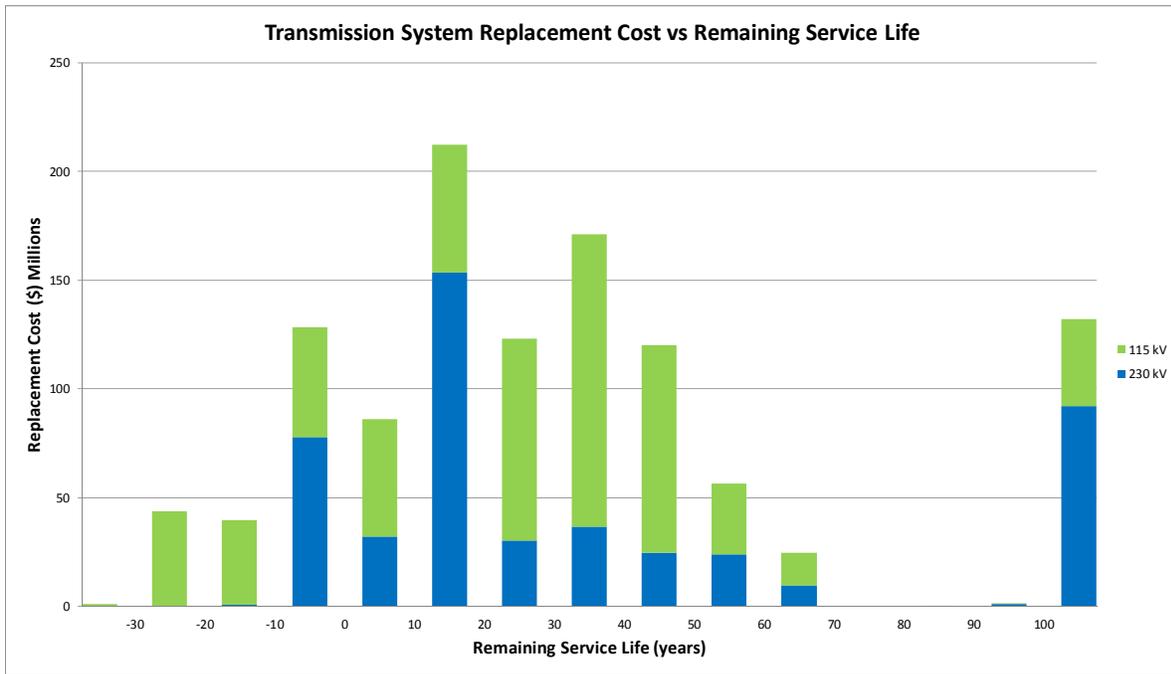
The next step is to look more closely at the replacement cost of actual installed assets compared to remaining service life. This provides the basis for levelized replacement budgets given actual remaining service life profiles, as summarized in the following chart.

Figure 3: Replacement Cost vs. Remaining Service Life

Note that field assets costing \$234 million to replace are currently beyond expected service life, based on their age and statistical predictions of mean time to failure (everything to the left of 0 years in Figure 3 above). The oldest and greatest quantities of these assets are 115kV transmission lines. This represents a significant risk to the continued reliability of the transmission system, particularly for those 115kV circuits with more than 10 years past normal service life.

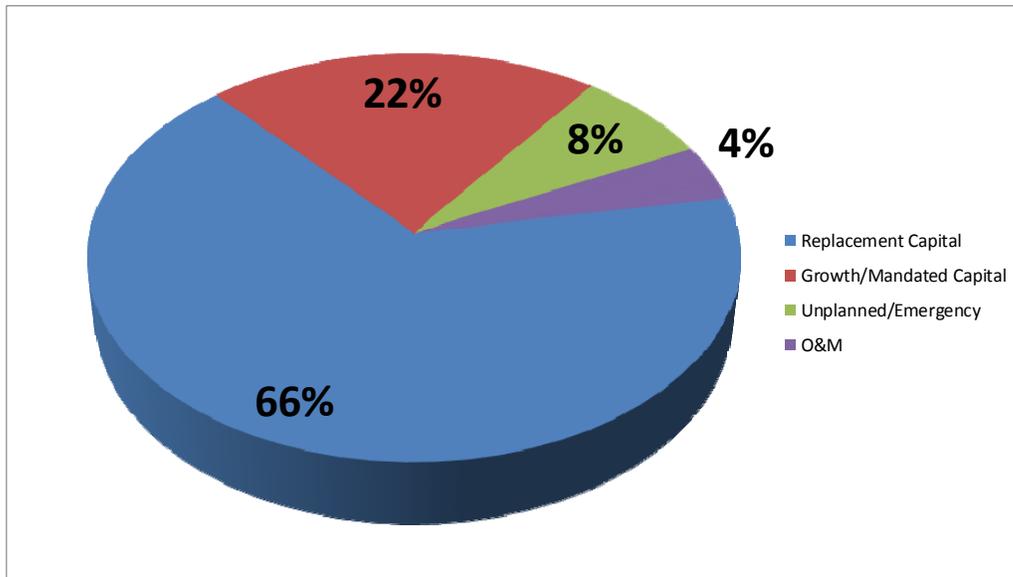
Figure 4: 2014 Planned Capital, O&M, and Emergency Spending

This shows that approximately 92% of spending was planned, vs. 8% unplanned in 2015. The percent of planned work should increase as planned replacements ramp up and unplanned/emergency spending is held constant or reduced. Growth and mandated projects (e.g. LiDAR projects) of \$6.3 million resulted in 22% of total Transmission spending in 2015. Although the spending in this category is highly variable from year to year, a constant value of \$3 million is assumed for the future. A small increase of 2% per year is assumed for reimbursable projects such as road moves. O&M dollars may be reduced over the long-term, due to expected lower inspection costs of steel poles as they are used to replace existing wood poles; however, this was not accounted for as it is somewhat uncertain and represents a relatively insignificant sum. Other figures represent recommendations for planned replacement and maintenance programs as specified in the Programs section of this report. Optimal planned spending may vary considerably after making adjustments for actual condition assessments as inspections are completed, capturing economies of scale opportunities when rebuilding larger sections of line, and taking into account cost of capital considerations from year to year. Notwithstanding these variables, the numbers below represent the minimum recommended investment for consistent, planned transmission work in the years ahead.

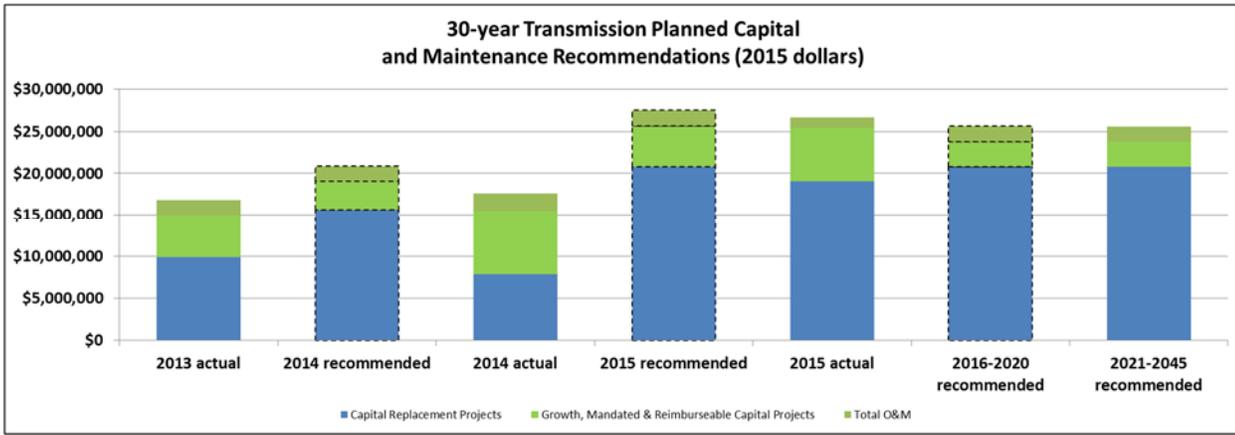
Figure 5: 30-year Transmission Planned Capital and Maintenance Recommendations

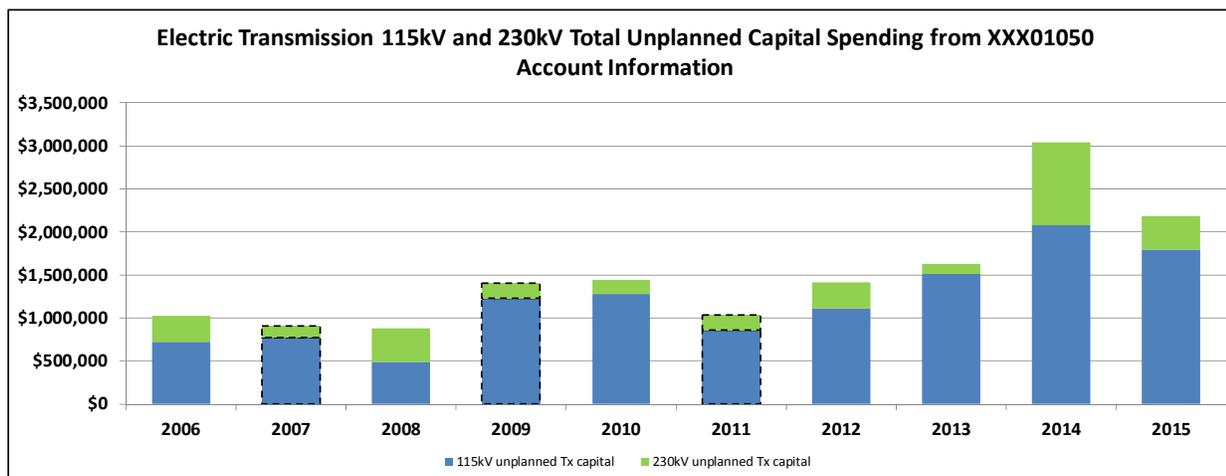
Unplanned spending represents capital replacement of those transmission assets that have unexpectedly failed and require prompt attention, typically by Avista crews (e.g. storm response events). Despite the variability that is correlated with fluctuations in weather intensity, unplanned spending is an especially important lagging indicator of system performance, trends, and the effectiveness of asset management programs. In addition to cost premiums incurred from overtime labor, unplanned work typically presents greater safety risks to the public and on-site Avista employees, as well as other risks including property damage, environmental, general liability, planned work delays, and additional rework costs following the event. We have set annual goals at the average of unplanned spending from 2009 through 2012, reflecting a desire to maintain system reliability. This results in “targets” of \$1.1 million for 115kV and \$210k for 230kV, for a total of \$1.3 million per year. Note that in past years we have consistently spent a much greater amount of total unplanned dollars on the 115kV system, at roughly four times the proportional value of capital assets when compared to the 230kV system. This is consistent with the fact that 230kV assets are felt to pose a higher potential consequence should they fail, and therefore we maintain them accordingly – deliberately effecting a lower frequency of unplanned events on the 230kV system, relative to 115kV. While this may be the case, it remains that the optimal target of unplanned spending has not been quantitatively determined for either system. This is a desired output from a future system model and analysis, involving the quantification and simulation of all significant risks and costs associated with unplanned events, maintenance and replacement work. Note that zero emergency spending is actually sub-optimal unless

Figure 6: 115kV and 230kV Total Unplanned Capital Spending

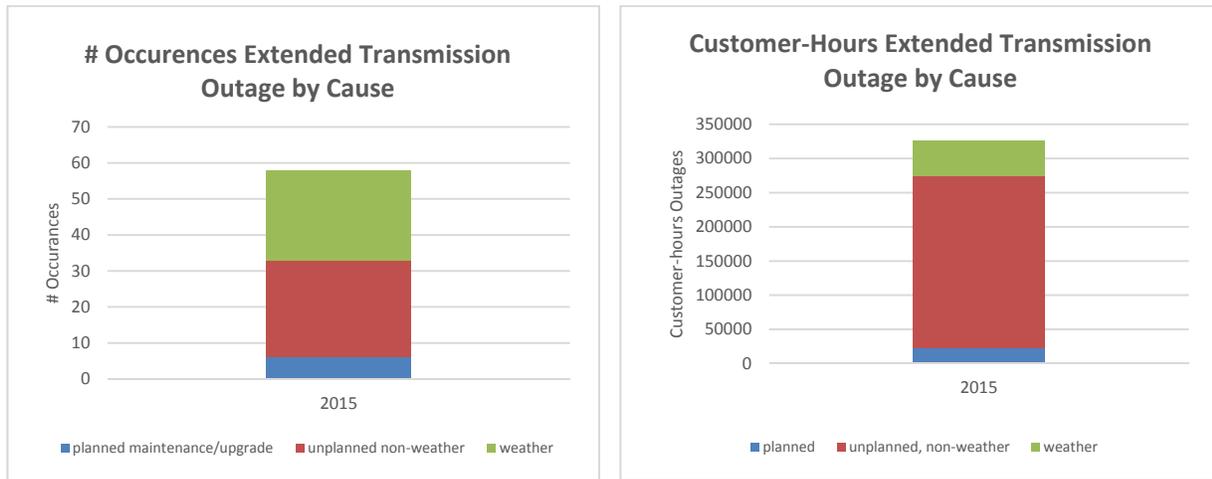
As can be seen from Figure 5 below, unplanned, non-weather and weather events dominate both the number of occurrences and customer-hours outages for the transmission lines.

Figure 7: Transmission outage causes affecting customers in 2015

Pole fire related outages continue to dominate both in terms of number of occurrences and customer-hour outages. At over 50,000 hours, pole fires had the highest number of customer-hour outages. This number is higher than last year (29,000 customer-hours) and highlights the need to continue the fire retardant program and to replace wood poles with steel poles.

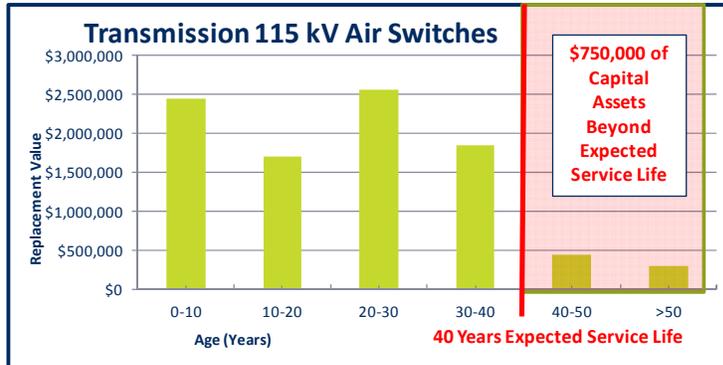
Typically three to four TAS are replaced each year. A detailed inventory of 115kV TAS outside substations was completed in 2013, including determination of age where formerly 20% of the assets were unknown. TAS inventory includes 180 switches of various types and configurations, as shown below according to remaining service life. Based on this profile, levelized replacement should increase to five replacements per year, requiring an increase to \$264,000 from the current \$225,000 annual budget. Annual budgets should be prioritized according to a rational condition assessment and quantitative risk assessment, rather than ad-hoc requests from field personnel and anecdotal observation which is the current method.

Figure 8: Air Switch Replacement Value vs. Remaining Service Life

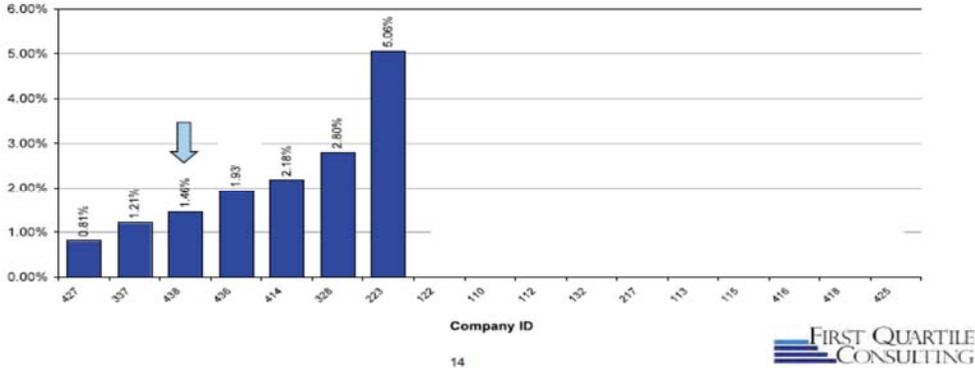
Asset replacement spending relative to other utilities is one area of particular interest. A 2008 study performed by First Quartile Consulting gathered data from 17 utilities of various sizes and geographic service territories in the U.S. and Canada, providing the 3-year average transmission line replacement capital spending per asset as shown in the figure below.

Figure 9: 3-year Transmission Lines Replacement Capital Spending per Asset (First Quartile Consulting, 2008)

This shows that out of seven companies providing data, the median was 1.93% and the mean was 2.41% over a three year period. Avista’s comparable replacement spending over the last two years and the recommended annual replacement spending over a 30-year period are shown in the table below.

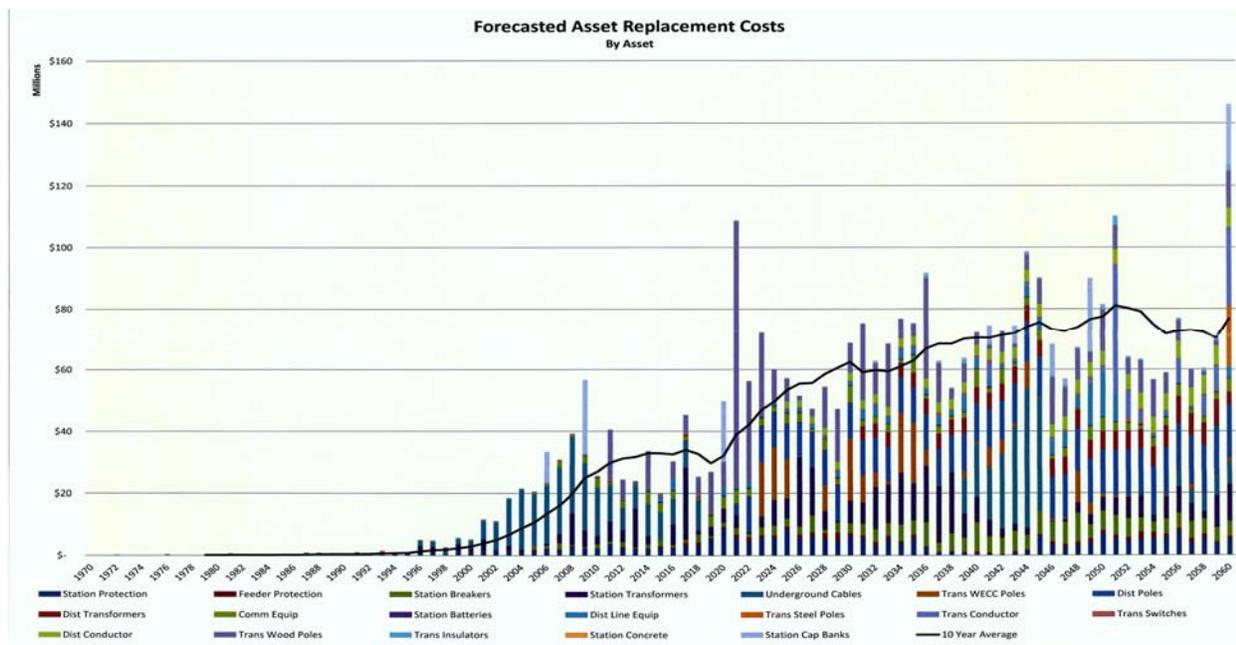
Idaho Power is also projecting a significant rise in capital replacement of aging infrastructure in the next several decades, as shown below. Over just the next 10 years, this indicates a total capital spend for Idaho Power of \$211 million for replacement of wood poles alone, or \$21 million per year levelized. This is similar in magnitude to the recommended replacement of aging wood infrastructure at Avista over the next several decades.

Figure 10: Idaho Power Long-term Replacement Costs

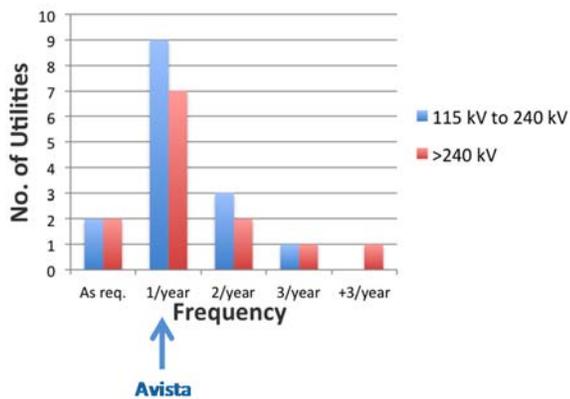
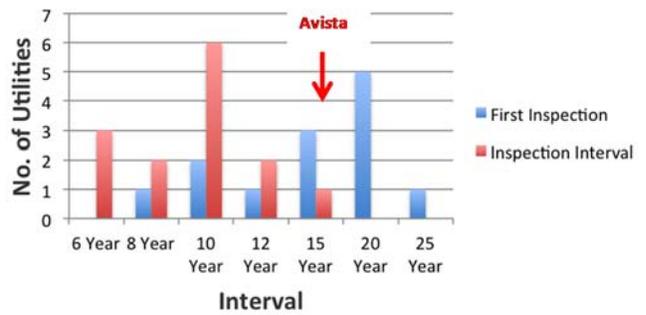
In terms of broader maintenance benchmarking, a study through a CEATI report (excerpts below) show that Avista is among the majority of peers conducting aerial patrols once per year, but that of all 15 utilities responding, we have the longest ground inspection interval at 15 years, as compared to the most common interval of 10 years.

Figure 11: Maintenance Benchmarking: Aerial Patrols (left) and Pole Inspections (right)

This does not necessarily mean that our inspection interval needs to be shortened. However, it does at least indicate where we stand relative to other utilities participating in the survey, and at minimum would tend to discourage extending our inspection interval any further.

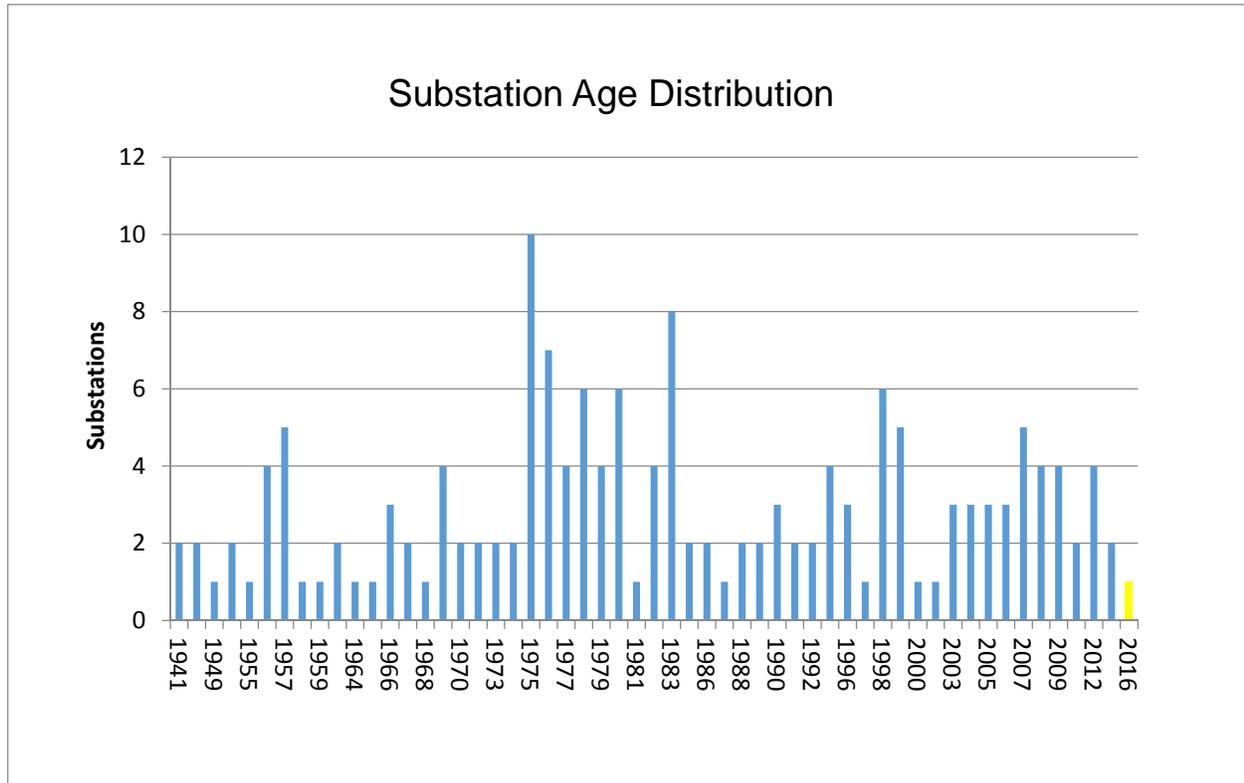
From a perspective of key equipment as reference, the average age of the 162 substations is just over 31 years. Figure 1 shows the age distribution of the substation population.

Figure 1: Substation Age Distribution

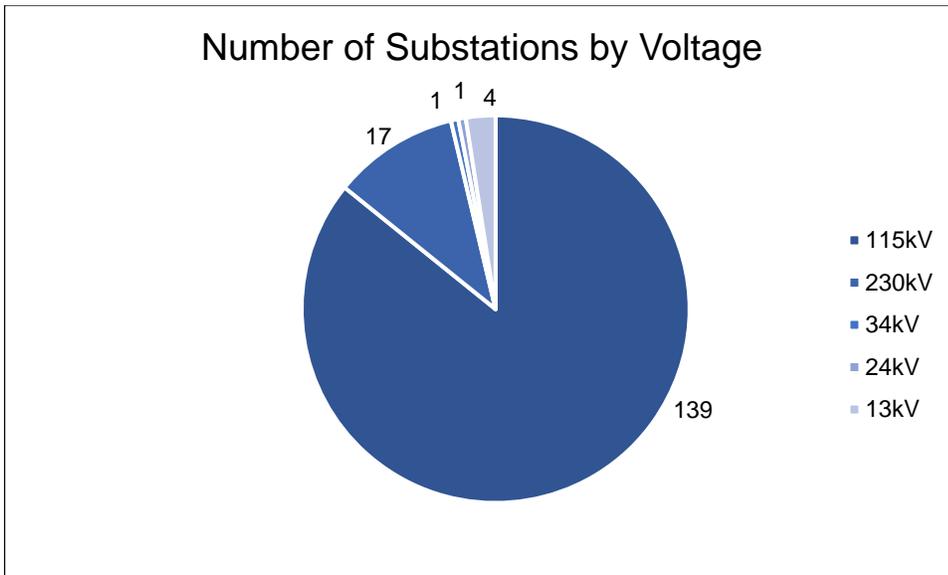
Substations are typically classified by voltage and function. The number of sites in each of these categories is included in Figure 2. In addition to the standard population of 230kV and 115kV substations, Avista continues to operate six substations at lower system voltages. These include the Kooskia substation at 34kV, the St. John substation at 24kV, and four substations at 13kV including Coeur d’Alene Shaft Mine, Sunshine Mine, and two at the Washington State University campus in Pullman.

Figure 2: Substations by classification

Included in the totals above are 13 switching stations, 11 in the 115kV group and two at 230kV, that do not incorporate voltage transformers or regulation. Standard interconnect and protection services are provided at these locations, supporting their inclusion in the general substation reporting.

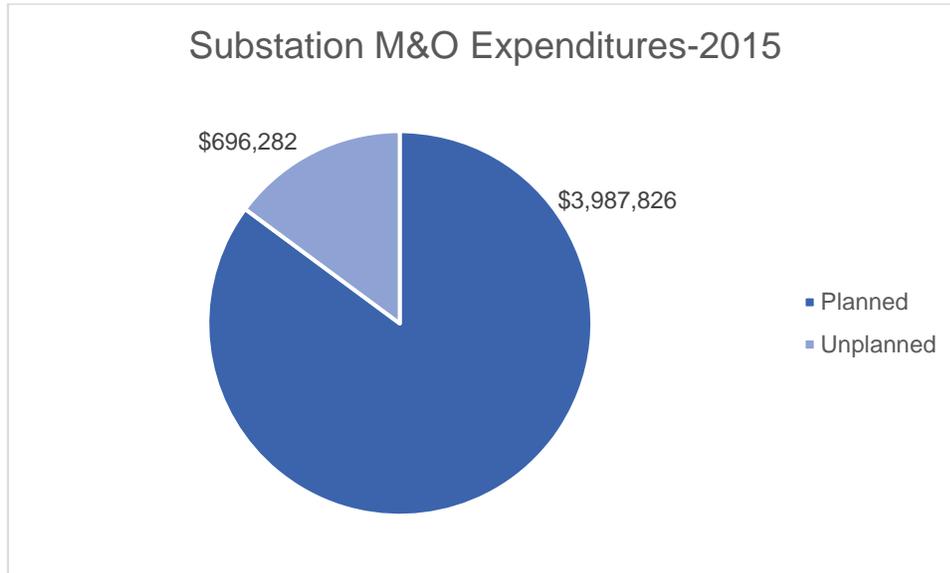
During 2015, a total of nearly \$4.7 million supported Maintenance and Operations activities relating to existing substations. As shown in Figure 3, approximately 85.1% of the maintenance and operation expenses were associated with planned services, while the remaining 14.9% was in response to unplanned or reactive activities. Figure 4 shows the total substation maintenance and operations spending by calendar month throughout 2015.

Figure 3: Substation M&O Expenditures

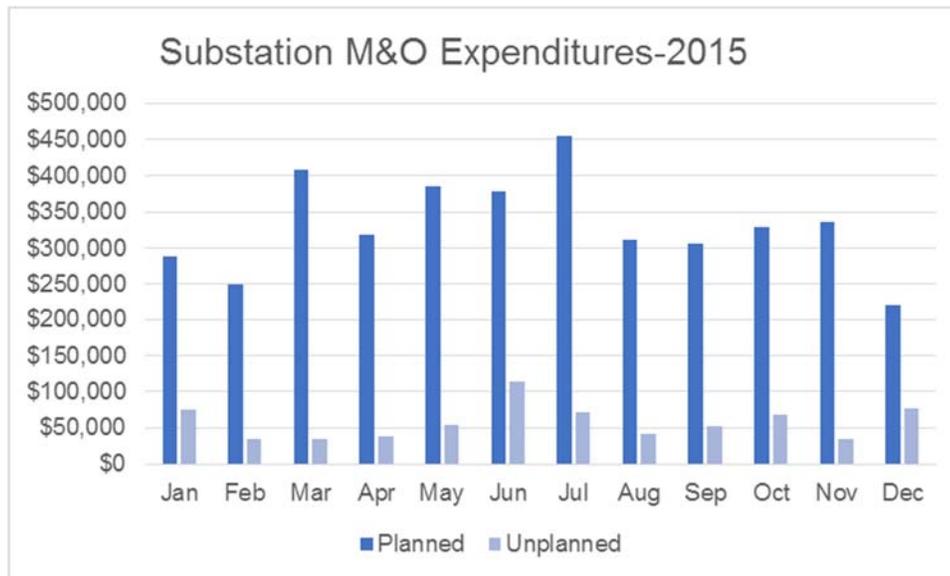
Figure 4: Substation M&O Expenditures by Month

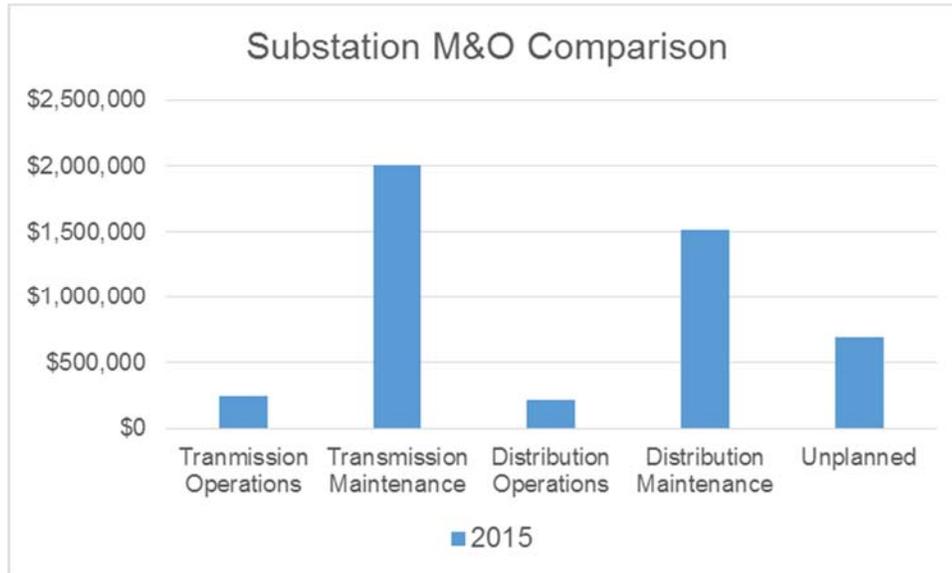
Substation maintenance activities are tracked by both distribution and transmission tasks. As noted earlier, many of the substation locations provide both distribution and transmission services. For 2015, the allocation between transmission and distribution expenses, both maintenance and operations, along with unplanned expenditures, are shown in Figure 5.

Figure 5: Substation M&O Comparison

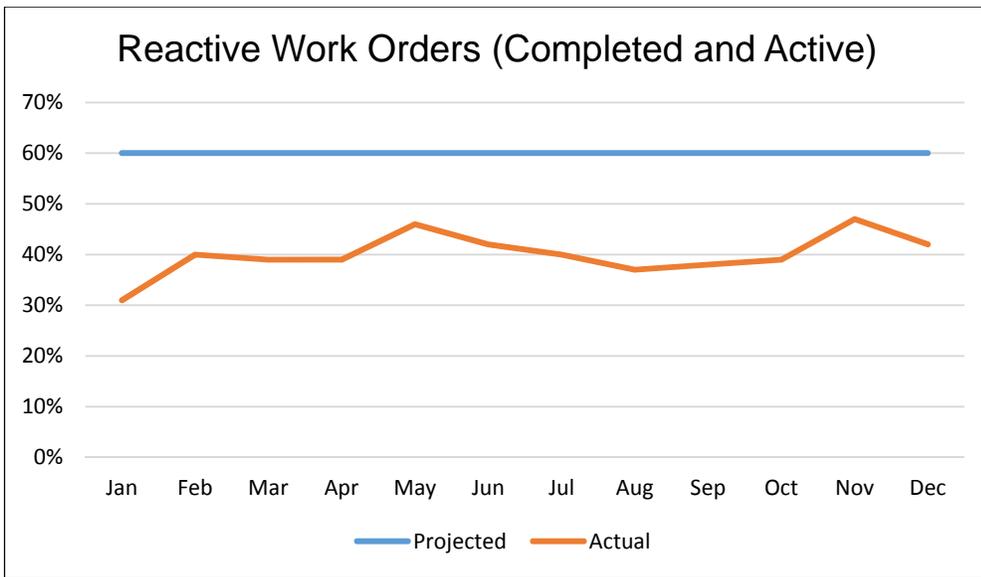
The KPIs in Figure 6 and Figure 7 show projected and actual metrics relating to Work Orders within Maximo. Reactive Work Orders are associated with required Corrective Maintenance tasks that were in response to operational malfunction issues or items requiring attention following a planned inspection. Throughout 2015, the projected target has been achieved. The Average Age metric tracks the rolling number of days existing Work Orders have been active. This metric continues to not meet the expected performance level, though this topic continues to be addressed with the Operations teams.

Figure 6: KPI-Reactive Work Orders

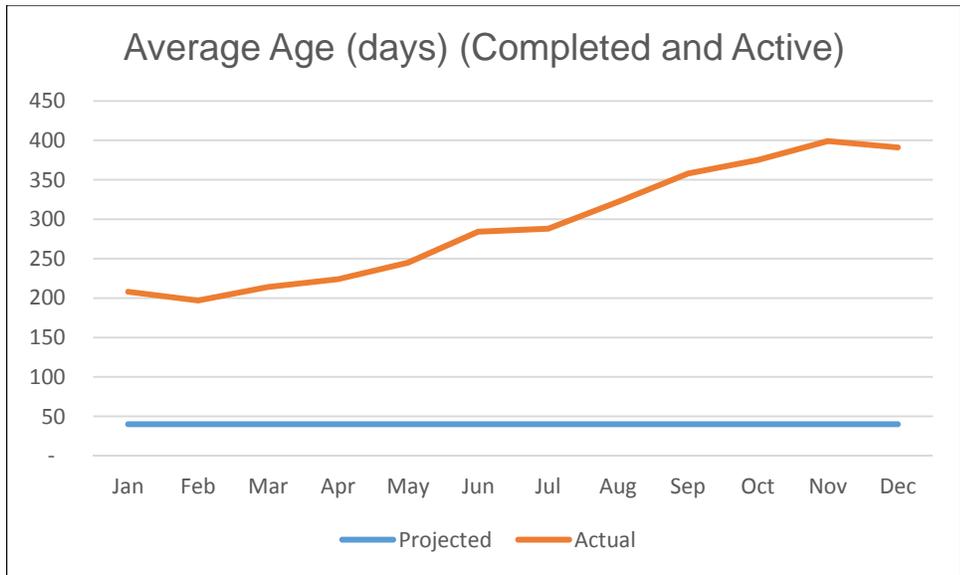
Figure 7: KPI-Work Order Average Age

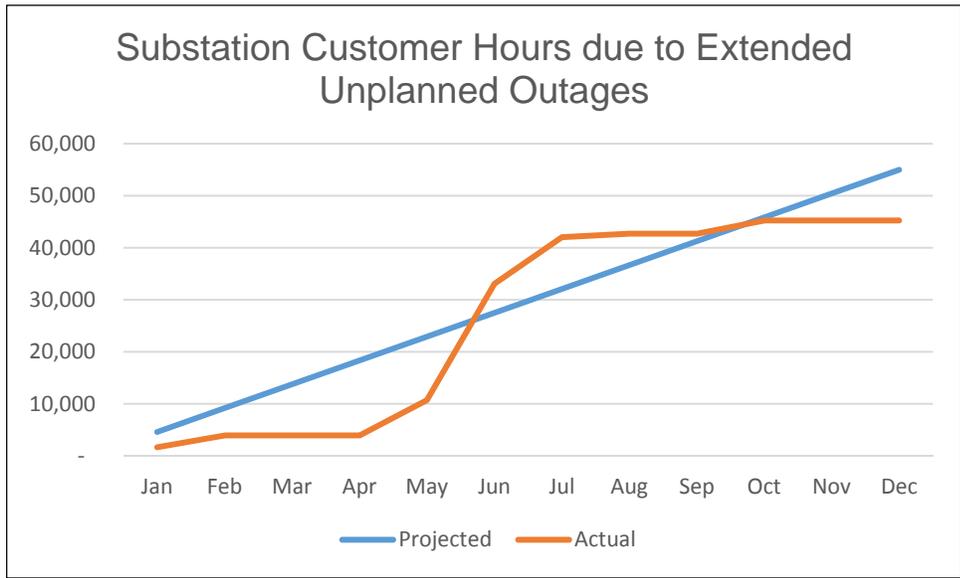
Metrics associated with customer outages due to substation activity are shown in Figure 8 through Figure 11. In 2015, the projected outage metrics, whether time or quantity, have typically been satisfied, demonstrating the expected reliability of service for the end customer.

Figure 8: Hours of Unplanned Outages

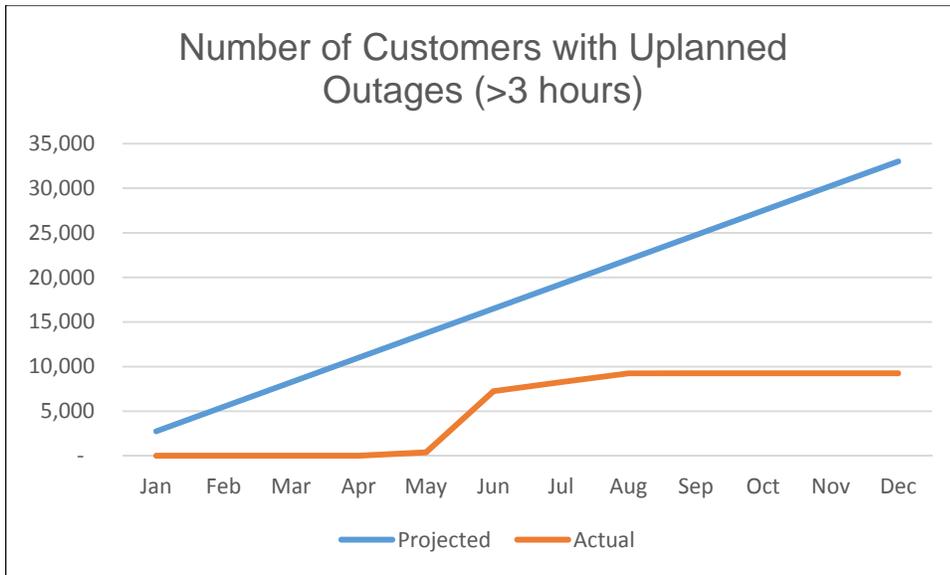
Figure 9: Customers Affected by Unplanned Outages

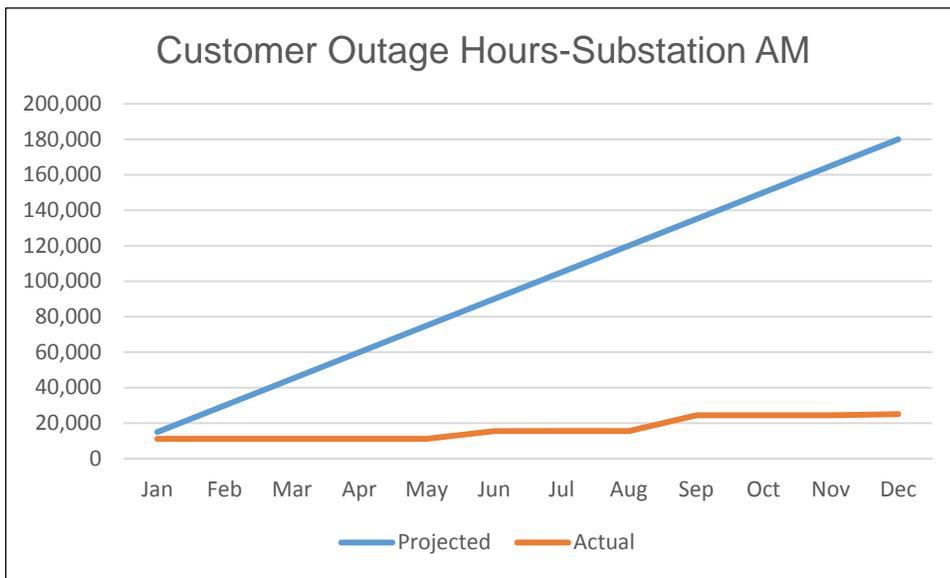
Figure 10: Customer Outage Hours

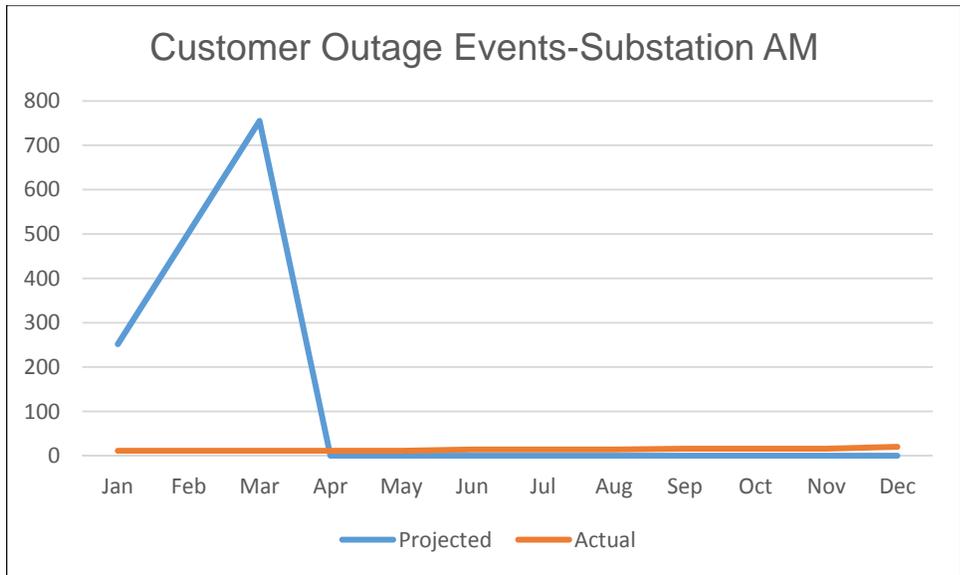
Figure 11: Customer Outage Events

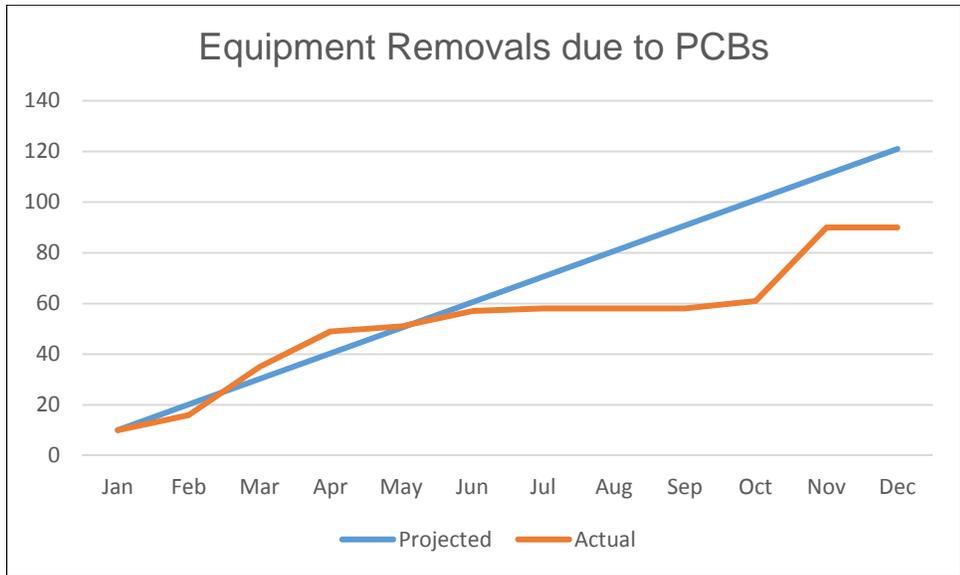
The metrics shown in Figure 12 through Figure 15 relate to specific substation equipment-related programs. Figure 12 identifies the equipment replacement activities associated with the PCB Removal program, including qualifying equipment removed from substations. Equipment identified as a PCB-containing device continues to be prioritized for removal or replacement in conjunction with other related activities. The remaining three graphs represent power transformer, voltage regulator, and air switch assets.

Figure 12: Equipment Removals due to PCB content

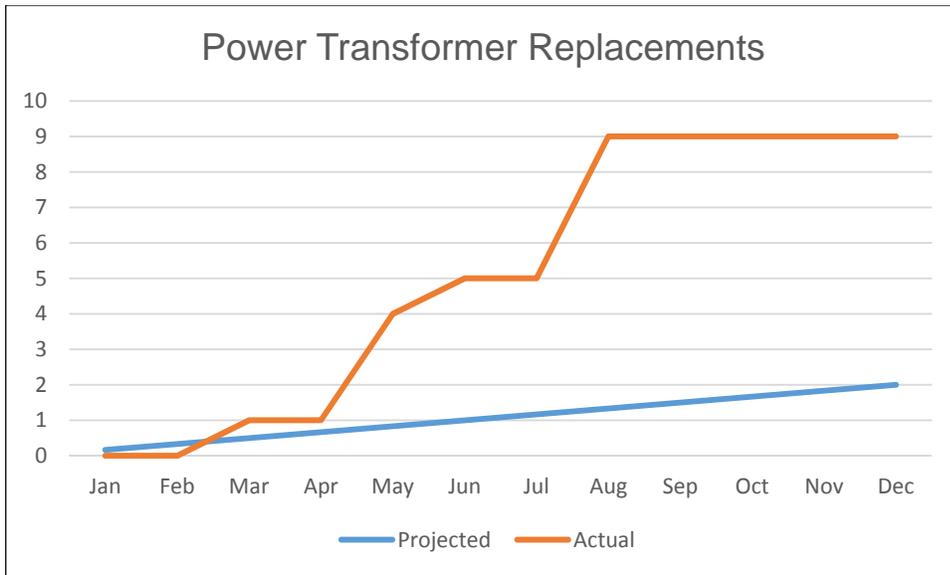
Figure 13: Power Transformer Replacements

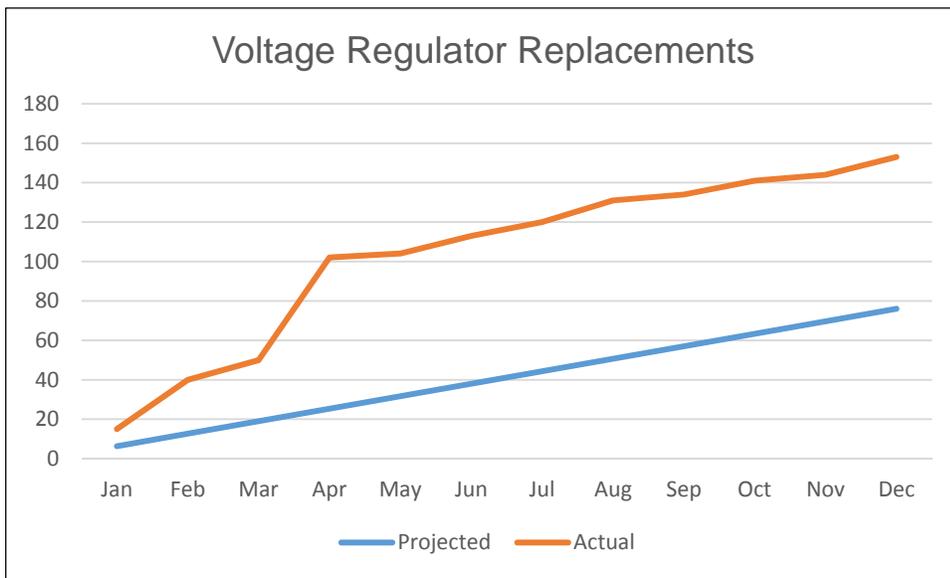
Figure 14: Voltage Regulator Replacements

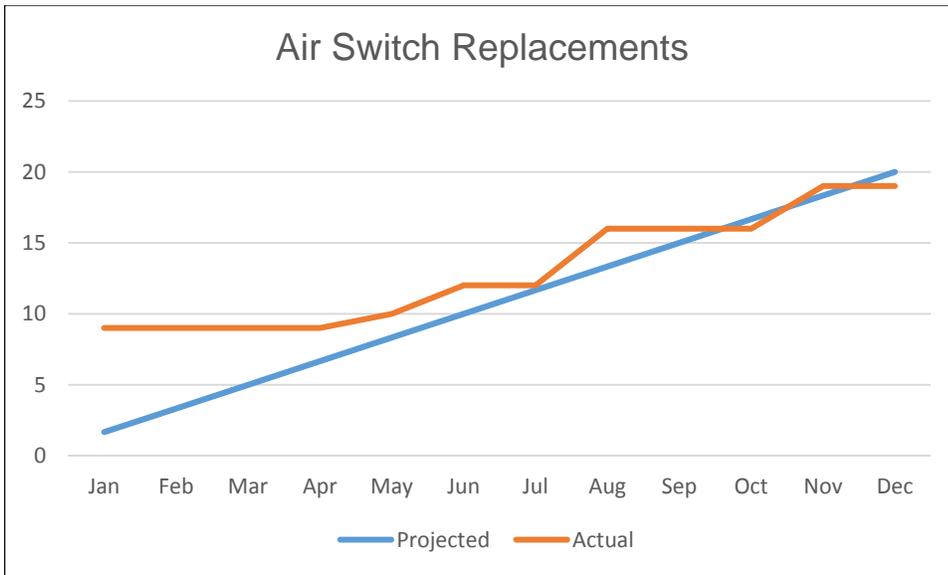
Figure 15: Air Switch Replacements

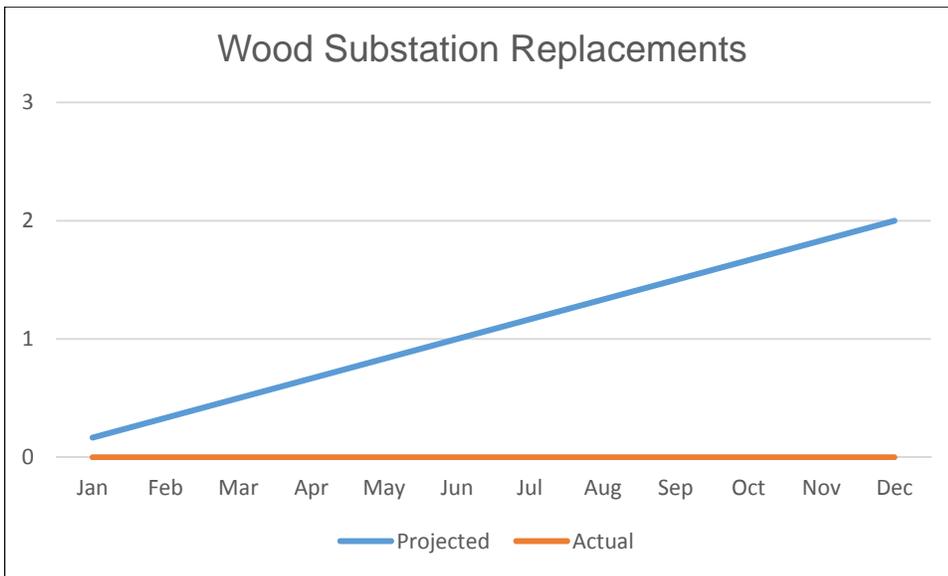
The Wood Substation Replacement program did not achieve a completed substation replacement during 2015 as noted in the graph shown in Figure 16.

Figure 16: Wood Substation Replacements

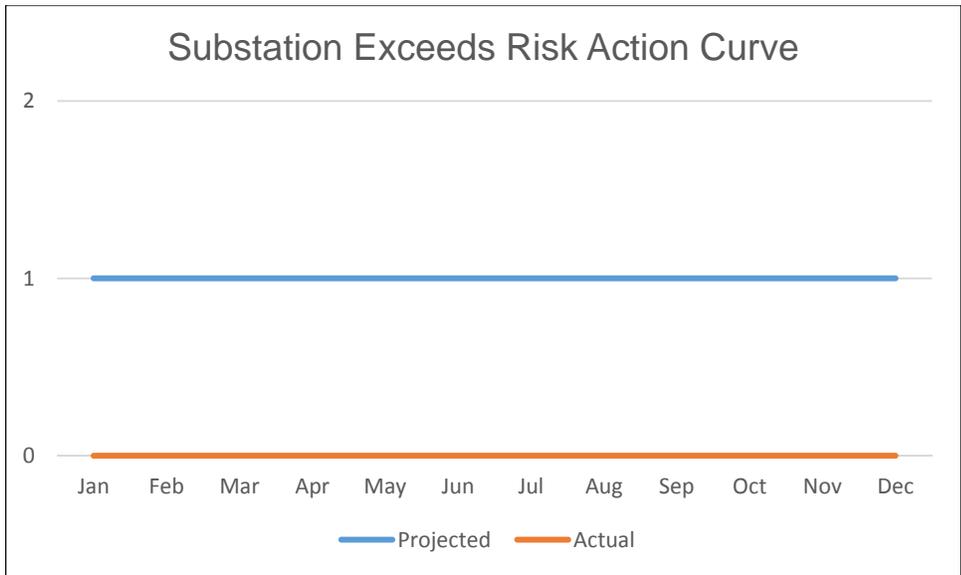
Figure 17: Substation Risk Action Curve

These final two KPIs evaluate system awareness criteria regarding level of service. The Risk Action Curve metric in Figure 17 tracks outage event parameters, including frequency and severity, to signal additional action if the accumulated outage activity requires further review and analysis. The OMT High Limit in Figure 18 tracks to an acceptable limits of service statistical metric for outage events.

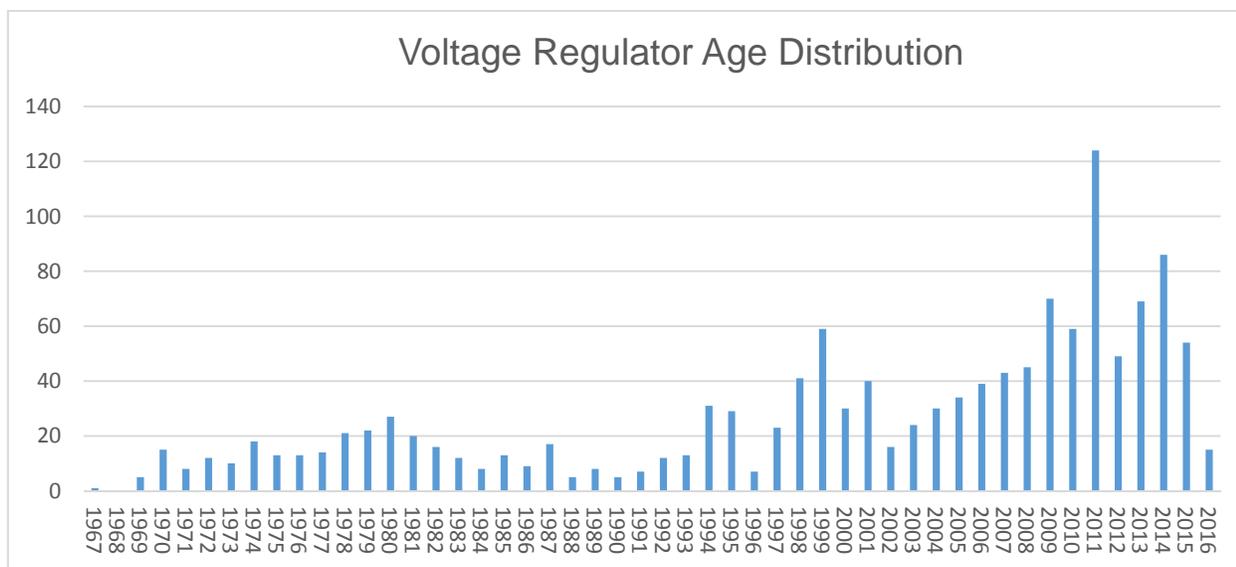
Figure 19: Voltage Regulator Age Distribution

Voltage regulators have been identified as significant contributors to substation reliability, and ongoing evaluation and modeling is in progress. The age profile is shown below Figure 19. In the conjunction with substation upgrades, older vintage voltage regulators are being replaced. The success of this ongoing program is shown by the shift in the age profile. Presently, the average age of installed base of voltage regulators is 15.5 years, though approximately 20% of the units have been installed for more than 30 years.

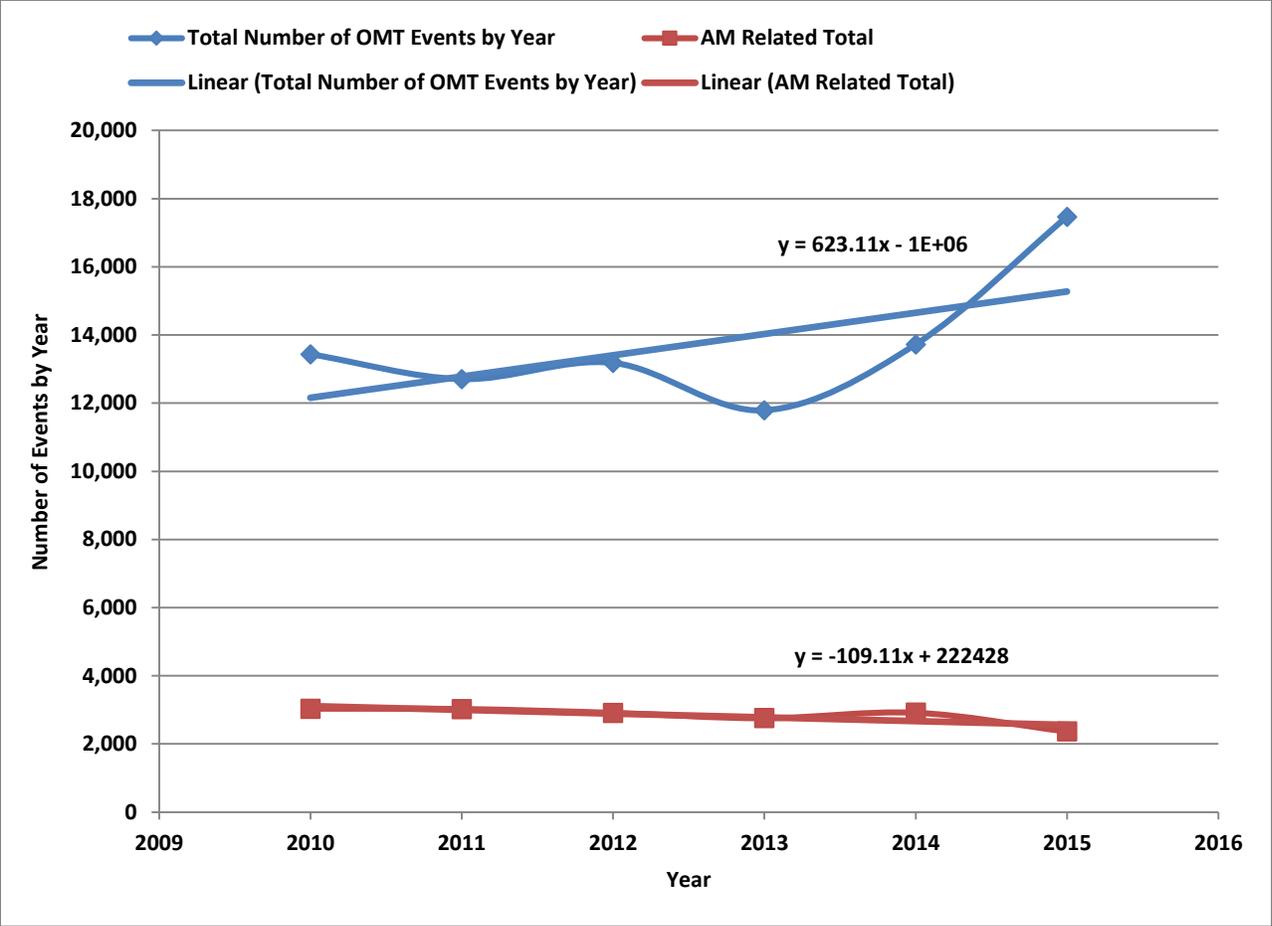
Figure 1, OMT Annual Number of Events and AM Related Event Trends and Trend Lines

The overall trends in OMT Events are shown in Figure 1 along with the trends in AM related OMT Events (see Appendix A of the “2010 Asset Management Electrical Distribution Program Review and Metrics” and the table titled “List of AM Related OMT Sub-Reasons” to see which OMT Sub-Reasons are considered AM Related). Based on Figure 1, Avista sees the trend in the number of events decreasing over the past 5 years.

AM related OMT events are actually decreasing at a rate around 4%. Since the regional growth rates are less than 2%, the decrease is most probably due to the increase in maintenance in the system and replacement of aged infrastructure.

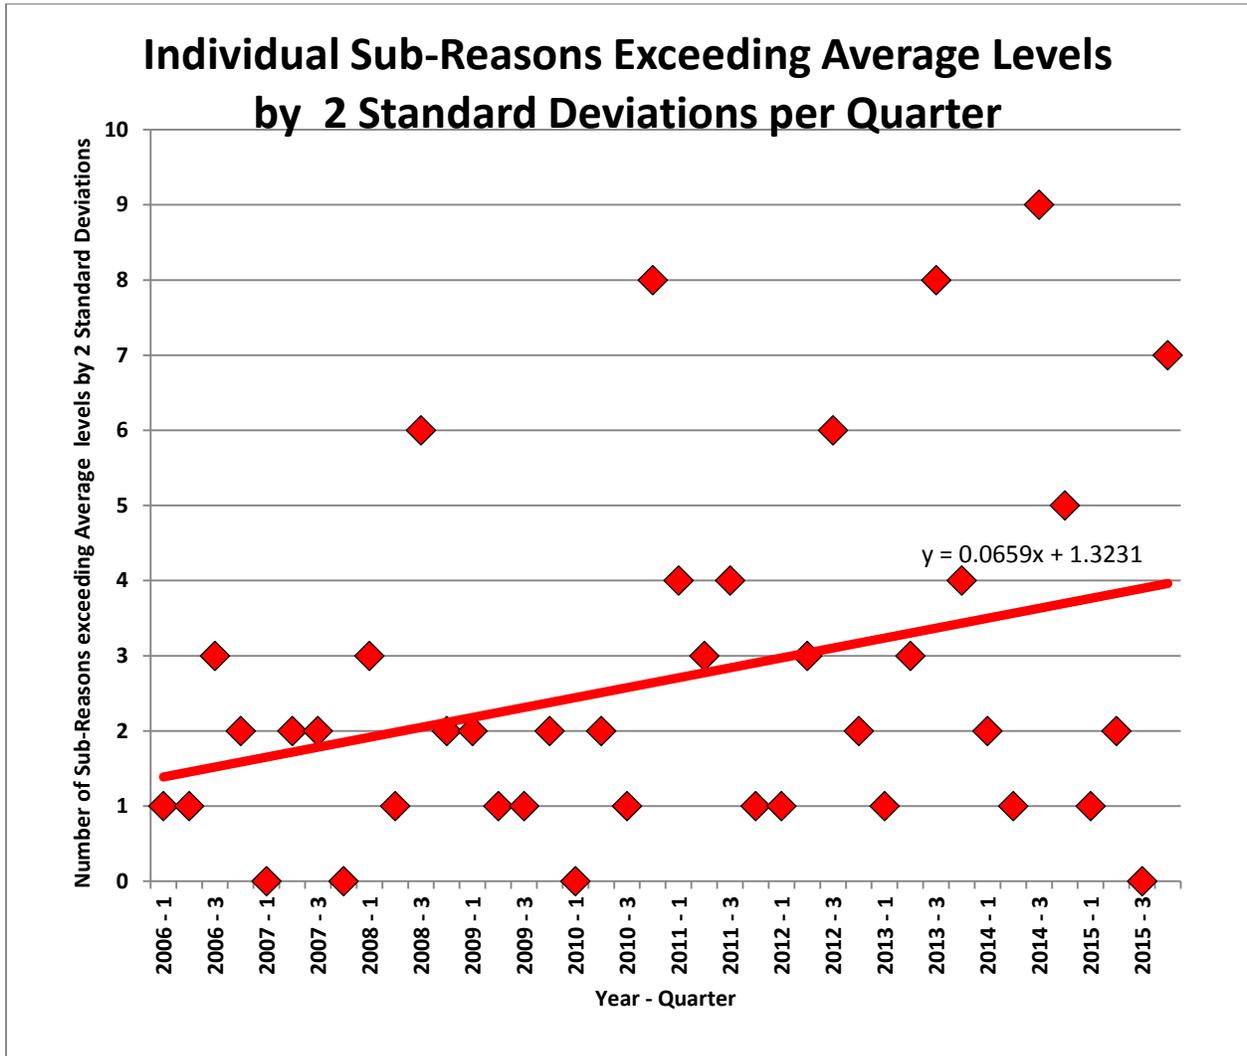
Figure 3, Individual Sub-Reasons exceeding Quarterly High Limits

Figure 3 shows the quarterly trends that feed into the annual trends for the OMT High Limit. For all OMT Sub-Reasons since 2006, only five Sub-Reasons have had more than five quarters where they

exceeded the High Limit, Car Hit Pole with 17 quarters above the limit, Conductor – Pri with 8 quarters above the limit, Fire with 6 quarters above the limit and Service with 9 quarters above the limit. This information is consistent with Table 6 above. We will continue to monitor Service for potential future action, but it currently does not warrant a maintenance or replacement strategy.
