BEFORE THE IDAHO PUBLIC UTILITIES COMMISSION

IN THE MATTER OF THE APPLICATION) CASE NO. AVU-E-16-03
OF AVISTA CORPORATION FOR THE)
AUTHORITY TO INCREASE ITS RATES)
AND CHARGES FOR ELECTRIC SERVICE) EXHIBIT NO. 7
TO ELECTRIC CUSTOMERS IN THE)
STATE OF IDAHO) HEATHER L. ROSENTRATER
_____)

Electric Transmission System 2016 Asset Management Plan

Mary Jensen, Rubal
Gill
Asset Management
Avista Corp.
02-01-2016

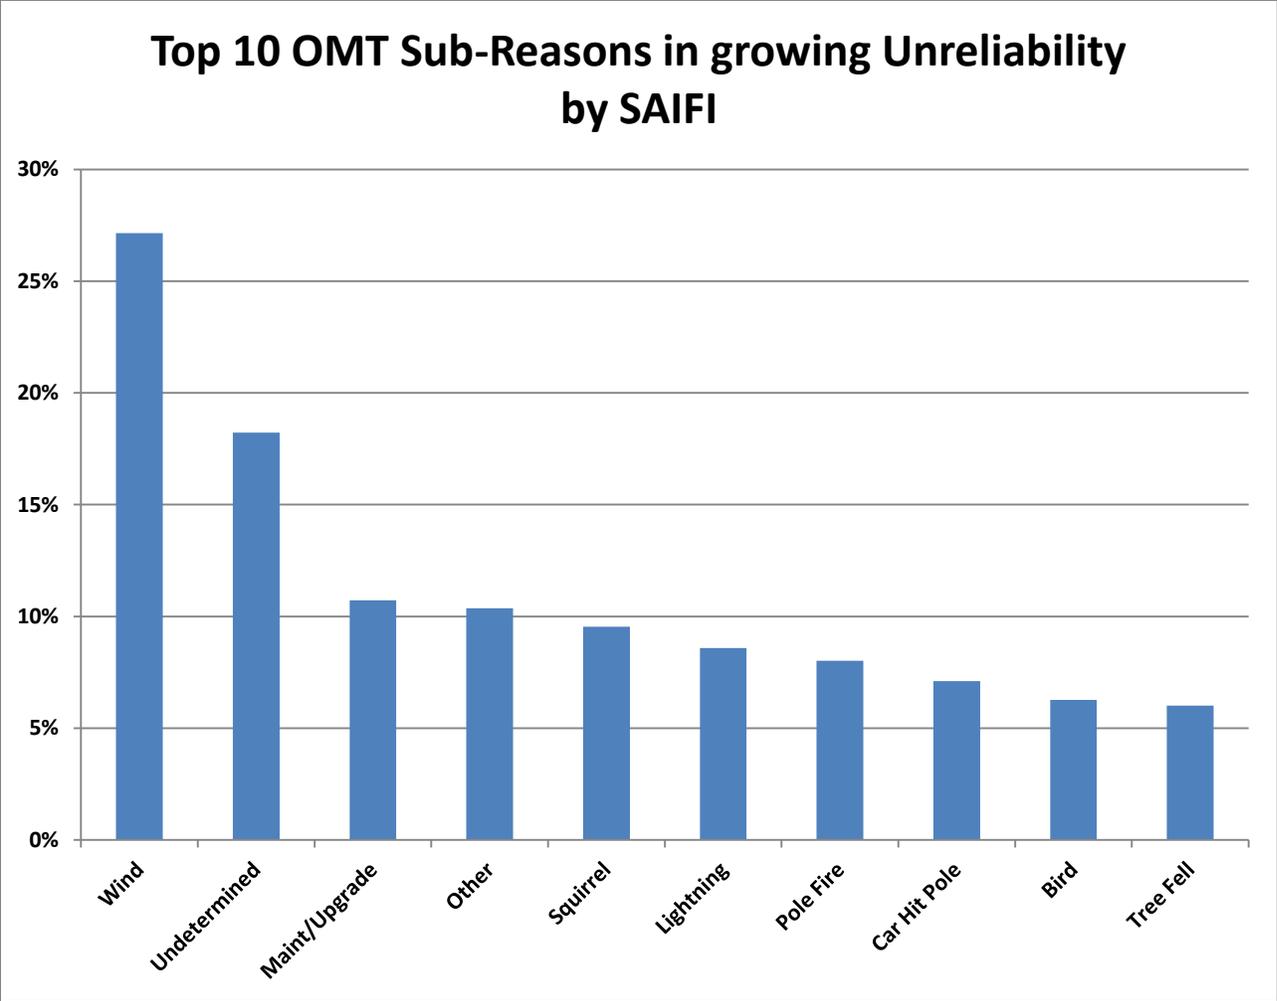
Figure 4, Top 10 Sub-Reasons with the Value of SAIFI Rising over Time

While most Sub-Reasons in OMT have fluctuating value around an average value over the past five years, some Sub-Reasons have demonstrated a definite trend upward as shown in Figure 4. Figure 4 shows the top 10 Sub-Reasons based on the percentage change in 2015. Some of the Sub-Reasons in Figure 4 do not have a significant impact on the SAIFI number, however, the trend for all of these Sub-

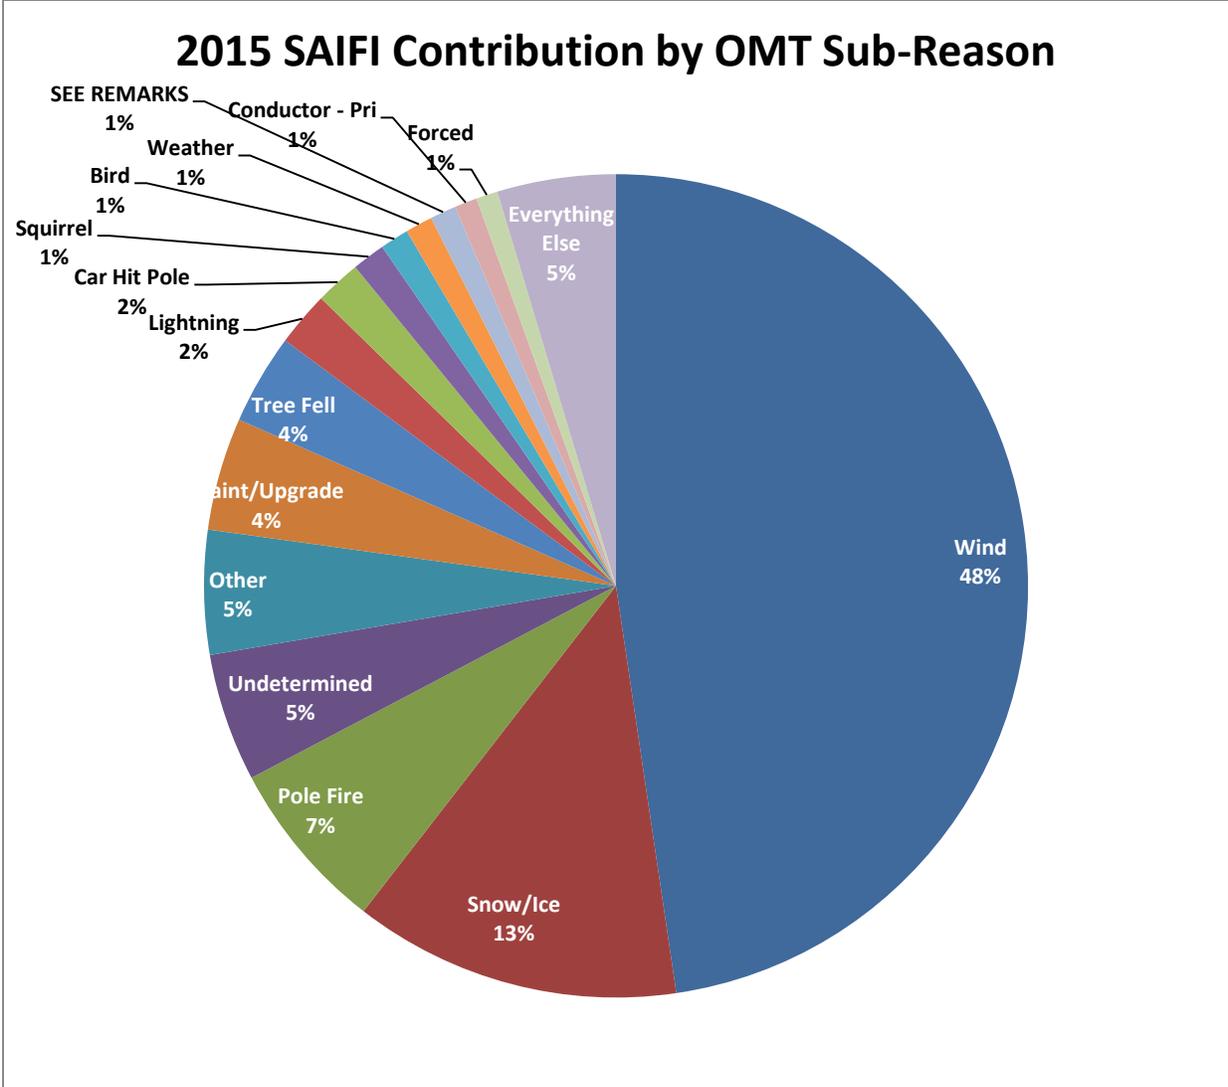
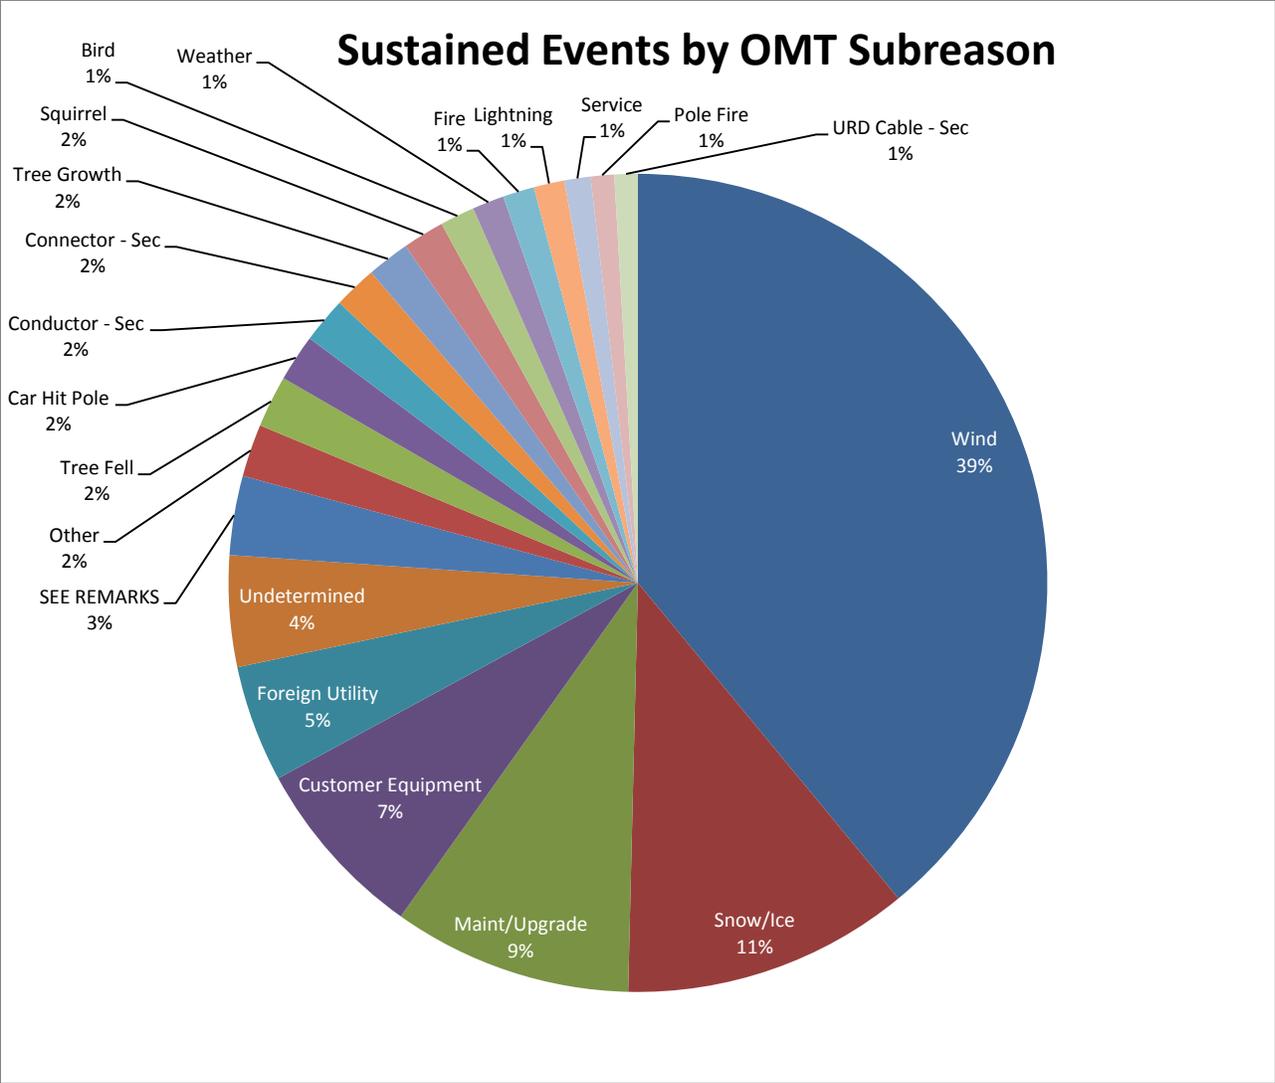
Figure 5 and Figure 6 illustrate the makeup of the overall SAIFI value and overall OMT Sustained Outages. Figure 5 and Figure 6 show a different result because the number of customers impacted by each Sub-Reason is different. For example, we have very few Pole Fire caused outages, but they affect a large number of customers. So, Pole Fire shows a significant impact to SAIFI in Figure 5 but is insignificant on Figure 6.

Figure 5, 2015 OMT SAIFI Contribution by Sub-Reason

Figure 6, 2015 OMT Sustained Outage Comparisons

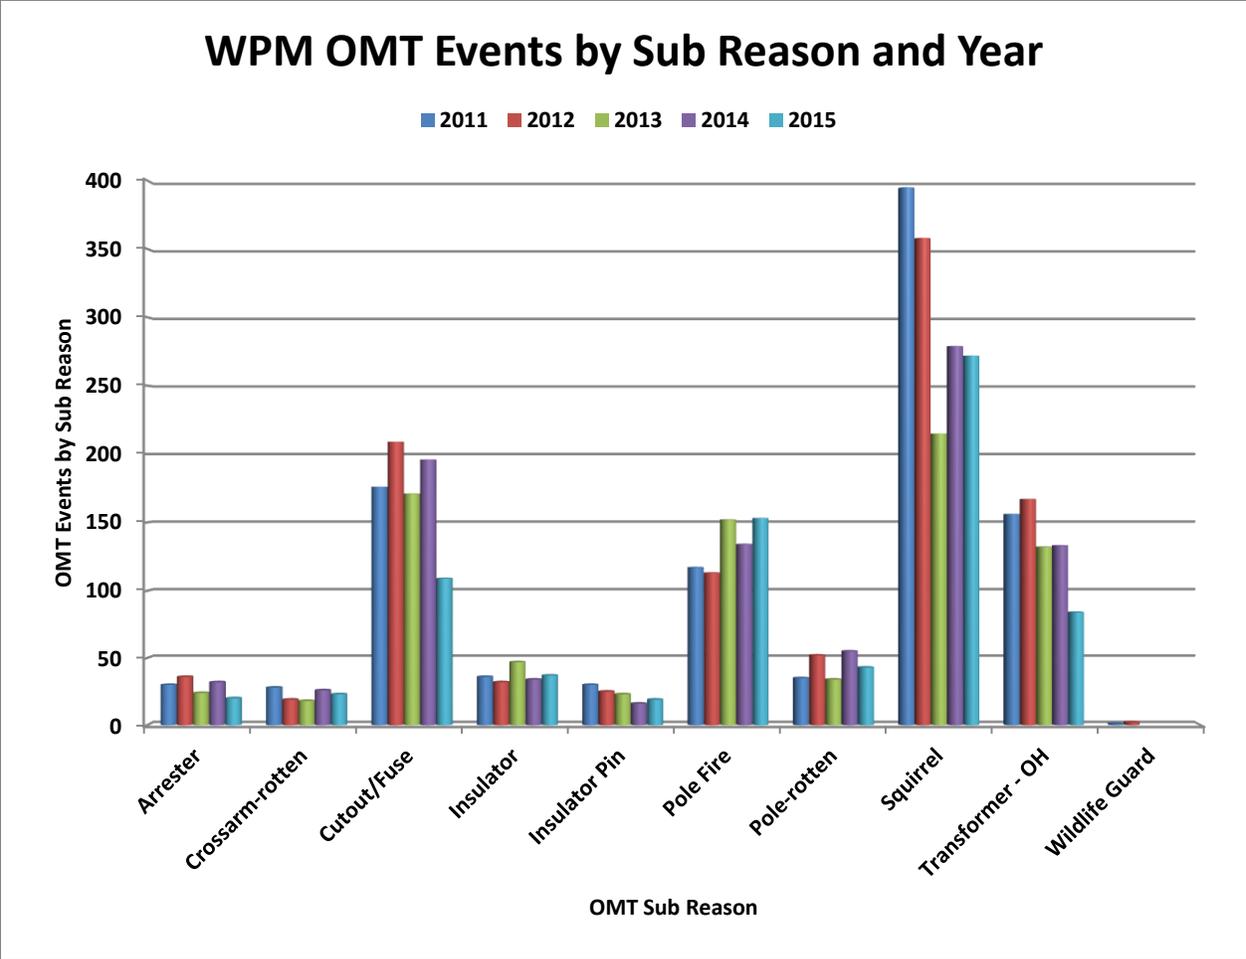
Figure 8, WPM OMT Event Trends

Figure 8 shows the trends in OMT events for the Sub-Reasons associated with WPM and generally the trend in OMT events is downward. The major contributors (Cutouts/Fuses, Squirrel, and Transformer – OH) all showed a level trend or a general trend downward over the past 5 years. Pole Fire had a slight increase this year but we had a dry hot summer which could account for some of the increase. Overall, WPM is controlling the number of OMT events. The leading indicator, Miles Follow-up Work Completed, shows we were falling behind in addressing issues identified during the inspection. If this backlog continues to grow, it will begin to impact the number of OMT events into the future. Funding limitations are preventing us from clearing out the backlog. We continue to strive to get funding for the back log.

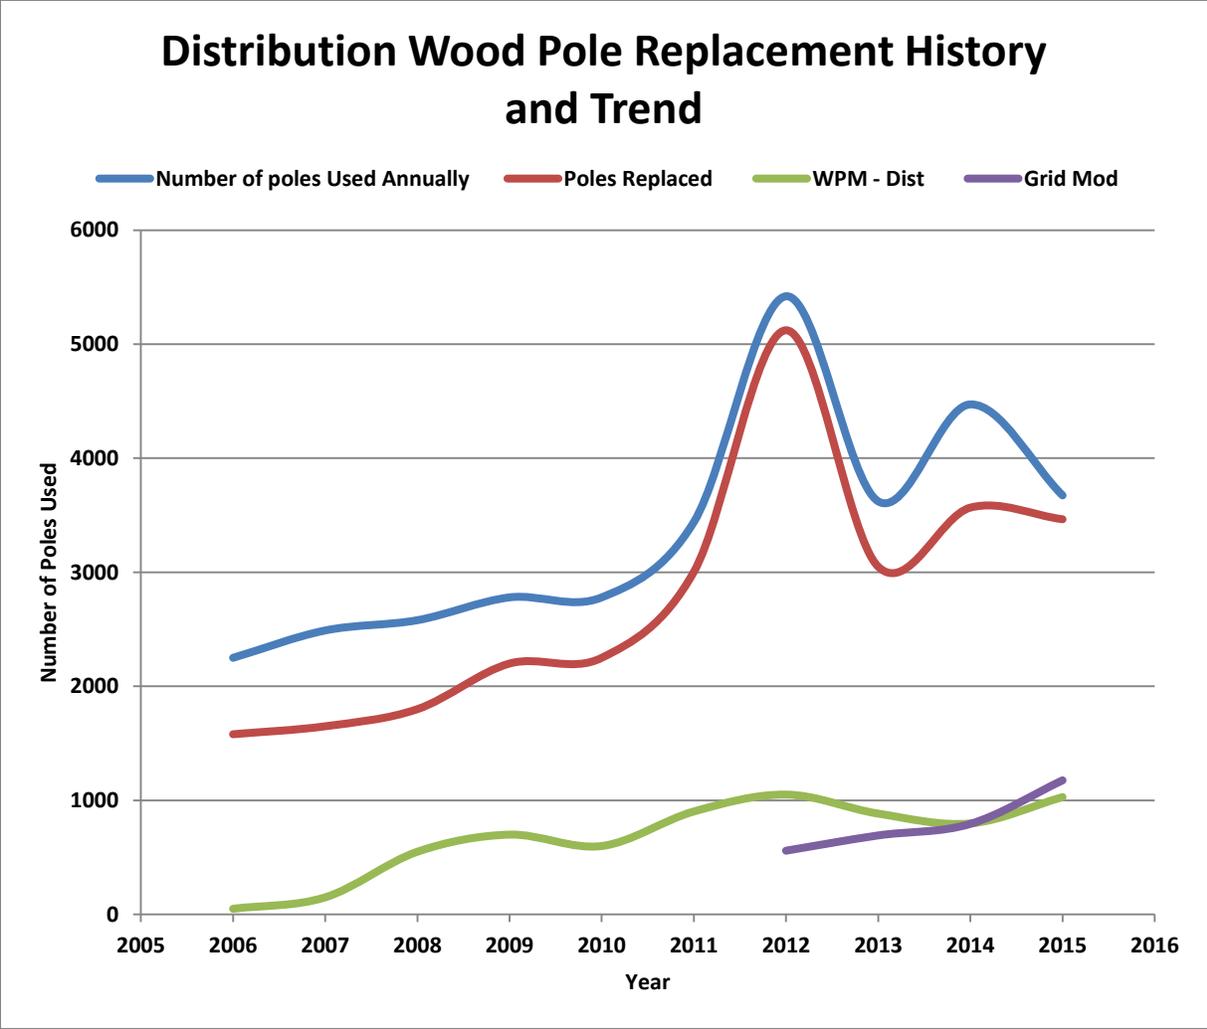
Figure 10, Wood Pole Used by Summarized Activity

Table 8. This is largely due to a budget cut towards the end of the year. The completed inspections are following the AM plan for WPM very nicely. Figure 10 shows how Avista's use of Distribution Wood Poles changed with time. This graph supports a growing number of pole and WPM related issues. Based on poles lasting 74 years before they will be replaced on a planned basis, Avista would need to replace 3,200 poles per year at equilibrium. We finally reached and exceeded 3,200 poles per year in 2011 and although the replacement is not a steady number we have remained above the 3,200 threshold since then. Figure 11 shows how an increasing number of poles are reaching 74 years.

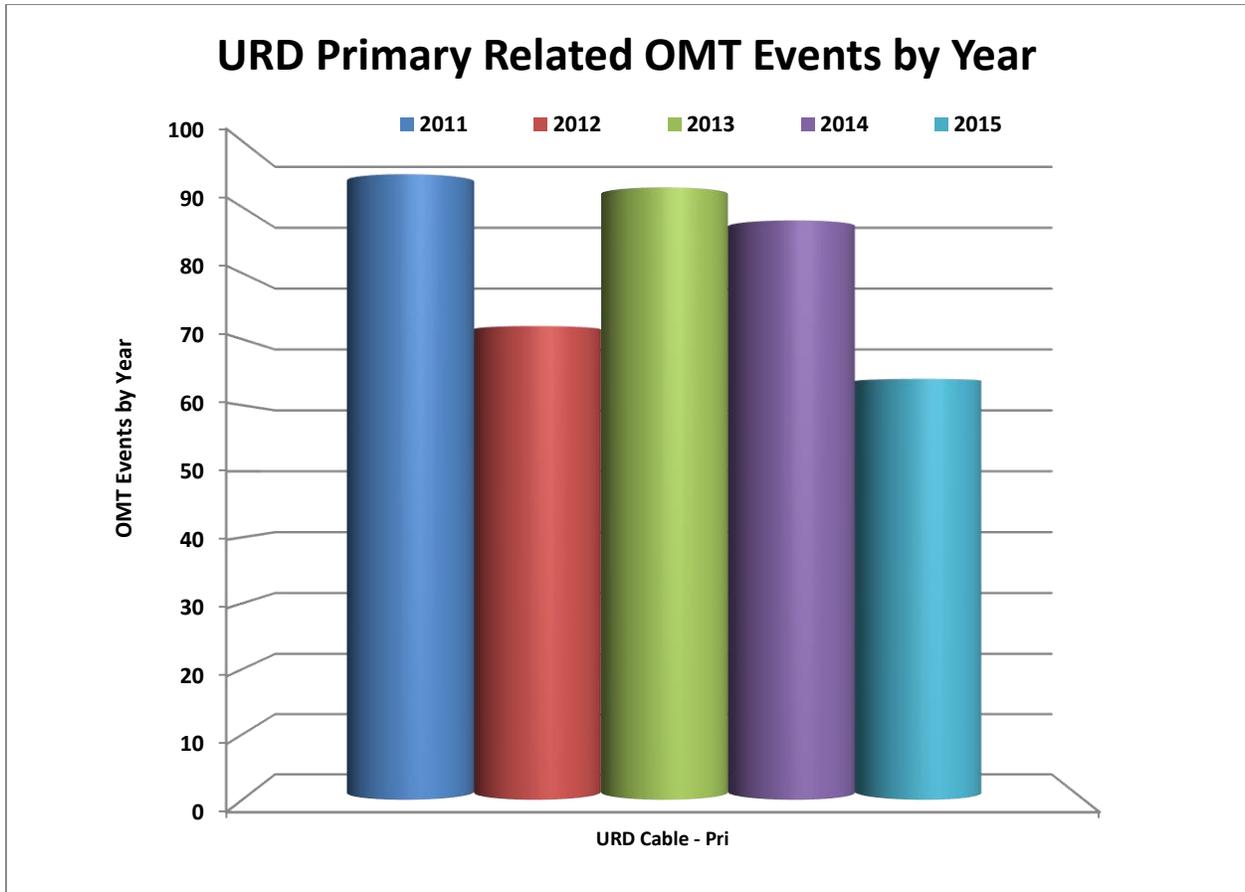
Figure 15, URD Primary Cable OMT Events by Year

For 2015, the performance for URD Primary Cable did not meet expectations but performed well. Table 12 shows that URD Cable – Pri events have not met expectations for the past couple years, however, the outages continue to have a downward trend. Figure 15 shows the downward trend in the number of events. The second generation of URD Primary Cable is also being analyzed. If it begins failing at an increasing rate, it would signal the next round of cable replacements. We have some faults in newer

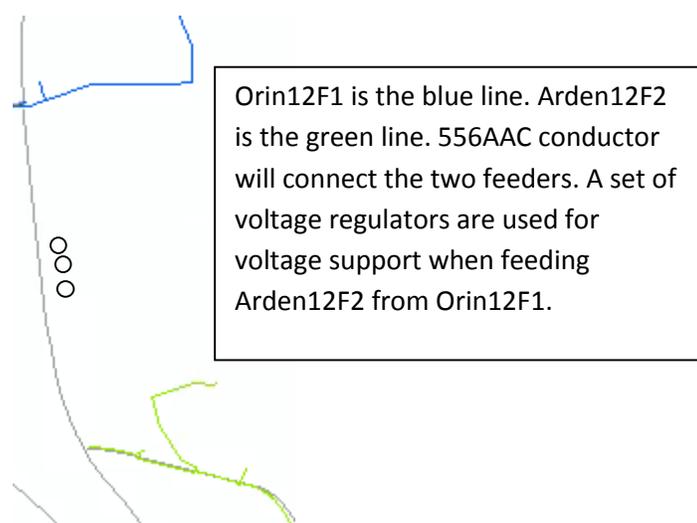
Figure 20, ARD12F2 to ORN12F1 Tie

This feeder tie project will allow the Arden12F2 distribution feeder to be fed by Orin12F1. The “tie” is being built by installing new conductor between the “gap” in the two circuits (see Figure 20). The conductor has a cross sectional area allowing it to pick up the load of Arden12F2. In addition the voltage drop of the “tie” conductor is small. Also, a set of voltage regulators is being installed to increase the voltage on the Arden12F2 feeder to keep it within the required limits. If there is an outage on the Orin12F1 feeder, the Arden12F2 will be able to pick up a portion of Orin12F1, but not the entire feeder.

This is a two year project with a cost of \$850,000 covering a distance of 2 miles between the two feeders.

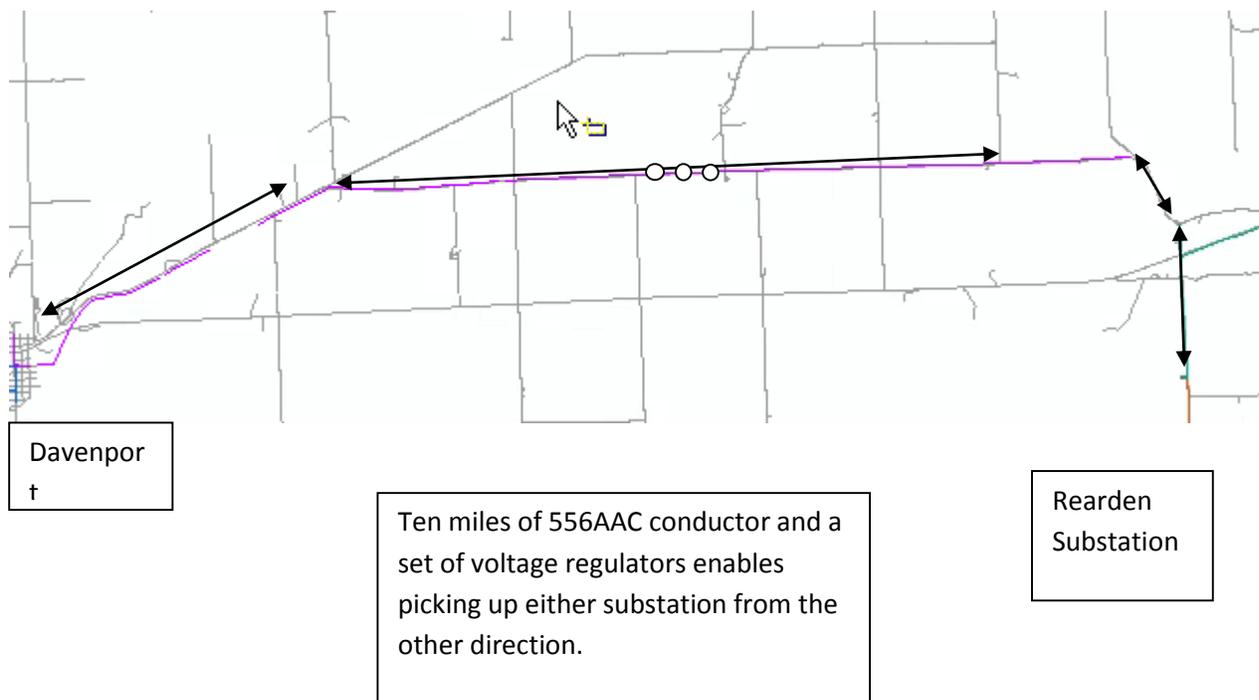
Figure 21, DAV12F2 - RDN12F1 Tie

This circuit tie will allow Rearden12F1 to be fed from Davenport12F2 and vice versa. The “tie” is being built by installing new conductor between the “gap” in the two circuits (see Figure 21). Also, a set of voltage regulators is being installed to increase the voltage on the host feeder to support customer service voltage.

This is a multiyear project with a cost of \$1.8 million dollars, connecting a distance of 10 miles between the two feeders.

At this point in time, approximately 5 miles of the tie circuit has been upgraded to 556 AAC. This new conductor will allow either substation to carry 4 MVA in the Summer, and 6 MVA in the Winter.

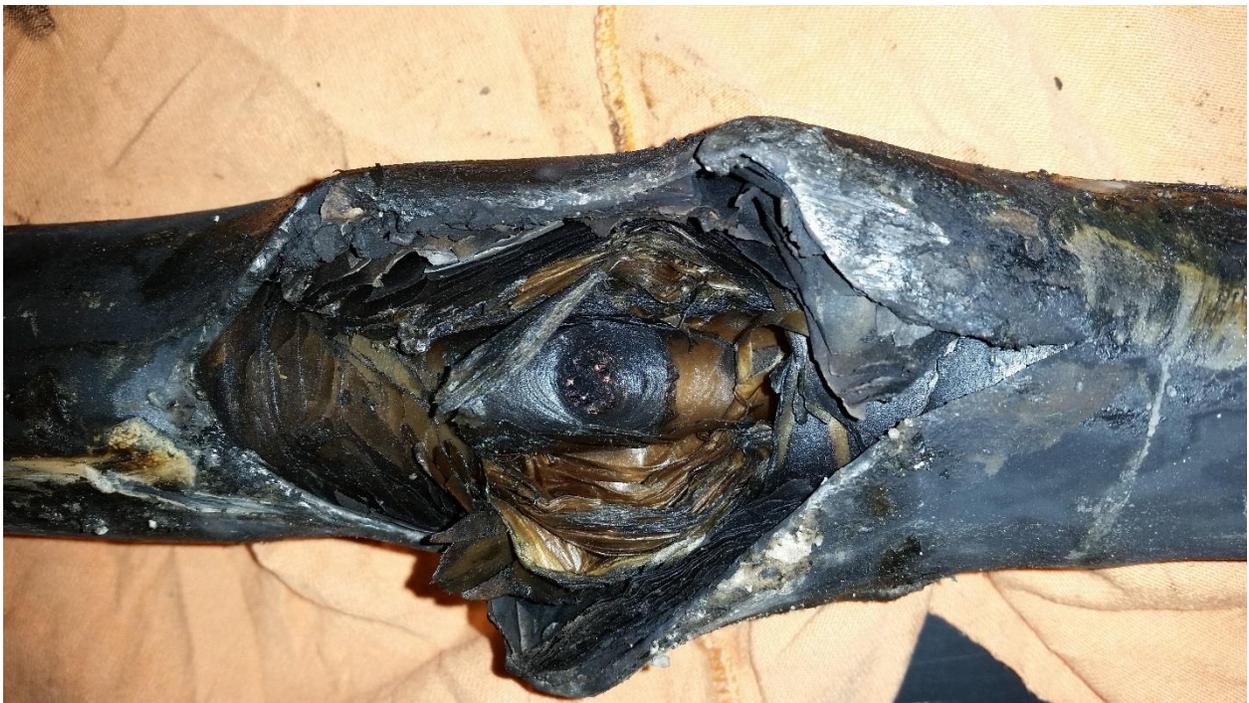
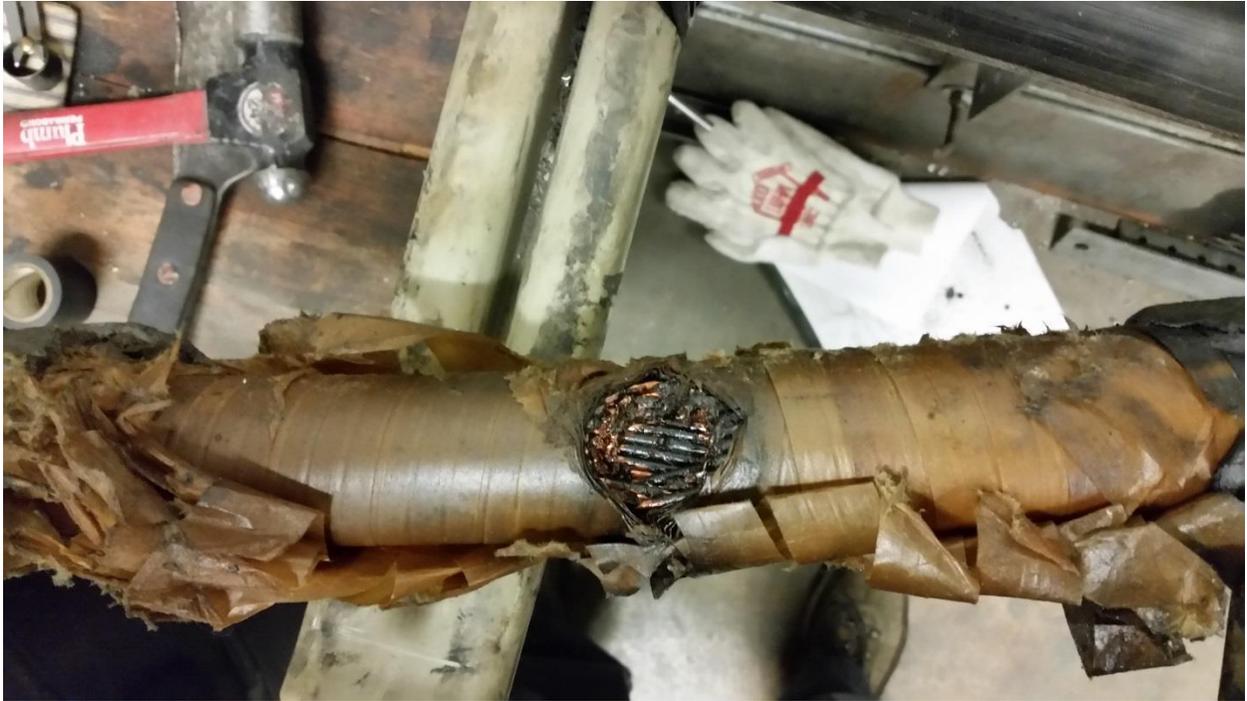
The PILC cable has been very reliable through the years of service; however, as it ages, we have observed an increase in failures. Our goal of maximizing service in the downtown network drives the PILC replacement effort. Figure 22 and Figure 23 are illustrations of failures that occurred with older PILC cable.

Figure 22, A faulted PILC cable

Figure 23, A second faulted PILC cable

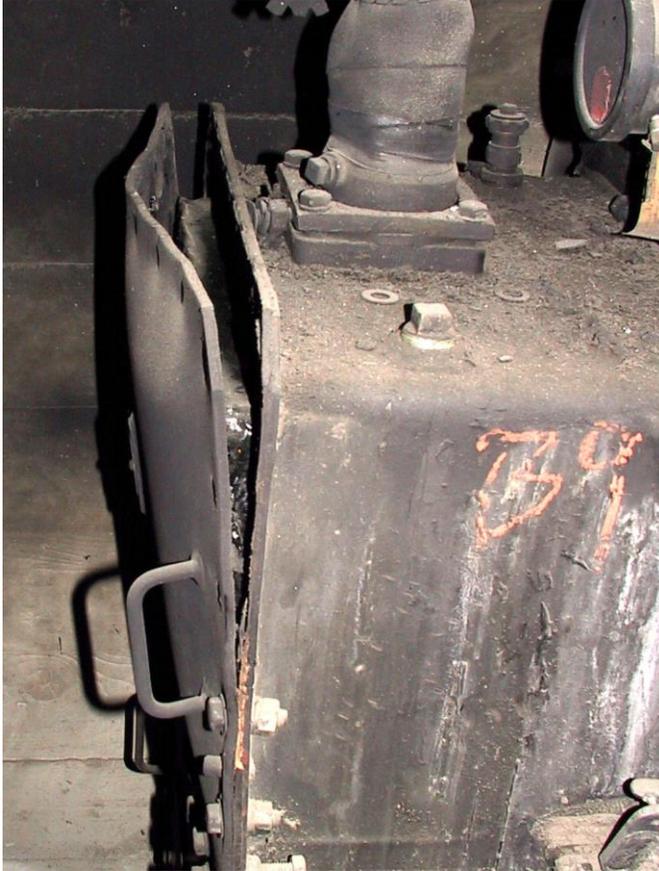
Figure 24, A network transformer after a failure in the primary compartment

A transformer failure can be a dramatic and dangerous event. Avista has been fortunate to not experience a violent transformer failure in recent years (a quick search indicates that the last one was in 2008.) Figure 24 illustrates the transformer which failed in 2008 due to some anomaly in the primary compartment.

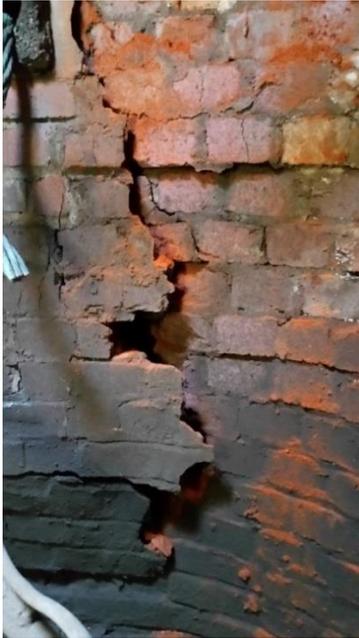
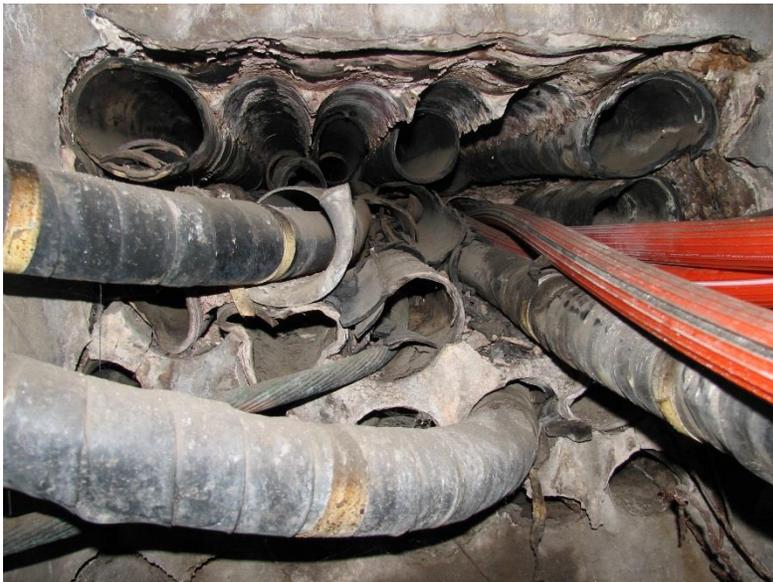
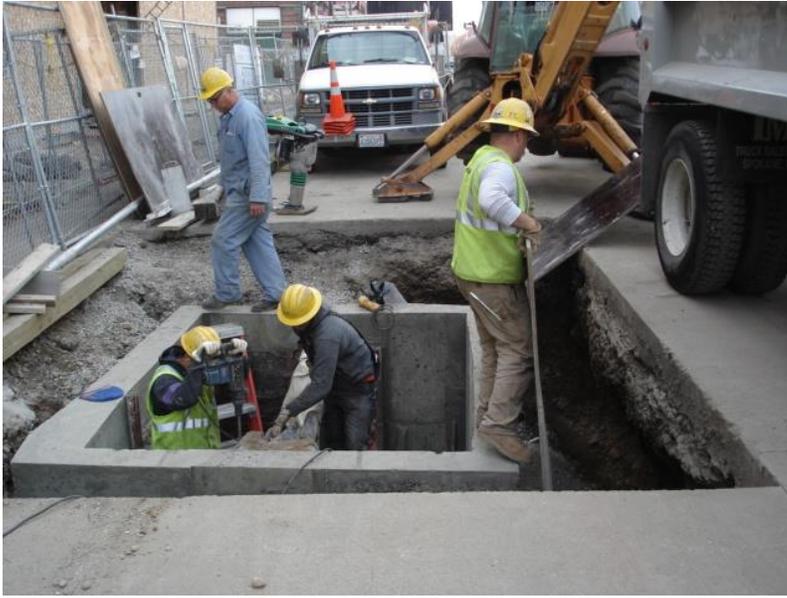
Mitigating the vault, manhole, and handhole deterioration has ranged from being as simple as installing a new lid to removal and replacement of the entire facility. Figure 25 through Figure 27 illustrate various underground facility deterioration we have recently found, and some of the remediation efforts undertaken.

Figure 25, Interior of a badly deteriorated old manhole in a heavily traveled street

Figure 26, Duct bank damage entering an old deteriorated manhole

Figure 27, Complete replacement of a badly deteriorated manhole
